HISTORIC STRUCTURE REPORT

The William Bonner House

110 EAST MAIN STREET
MIDWAY, UTAH

FINAL DRAFT REPORT
OCTOBER 2012

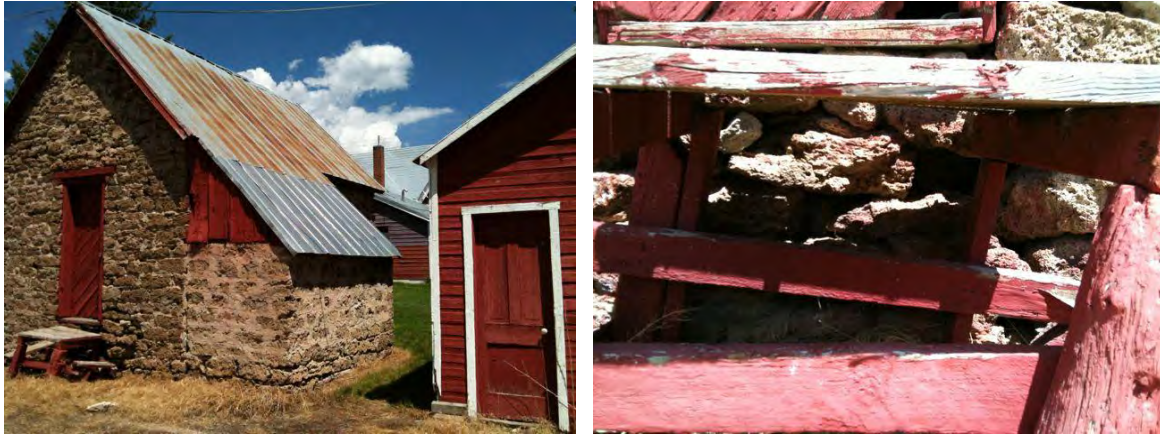
The foundations for the Granary range in condition from poor to satisfactory. It was observed in a few spots that the mortar joints have deteriorated to a point that the Pot Rocks have loosened and failed. See photos on following page.

Granary, with loose foundation stones and failed mortar. (Packer, 2010).

Repair any cracked and damaged areas of masonry foundations. All damaged mortar joints need to be repointed. Repointing is the process of carefully removing and replacing any damaged or deteriorated mortar joints. Care should be taken to redirect any surface drainage away from the Granary. Watering sprinklers should also be redirected so that they do not spray towards the structure.

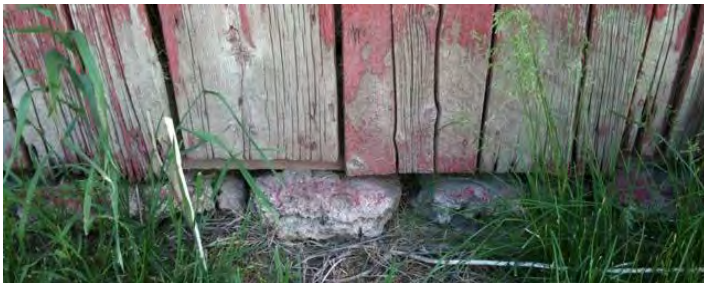
Barn foundation (cropped).
(Packer, 2010).

The masonry foundations for the Barn are in poor condition. Mortared joints were not observed and the exterior foundations did not extend down for frost protection. Without mortared joints, the foundation system does not work together as a single unit and thus the structure is susceptible to differential vertical and some horizontal movement. Without frost protection, the structure is highly susceptible to vertical movement between seasonal temperature fluctuations. Knowing the above information however was probably of no concern to the original owners, since the structure still is and was used as a Barn.

Due to the lack of an adequate long term foundation system at the Barn, it is recommended that the existing foundations be removed and new reinforced foundations provided.

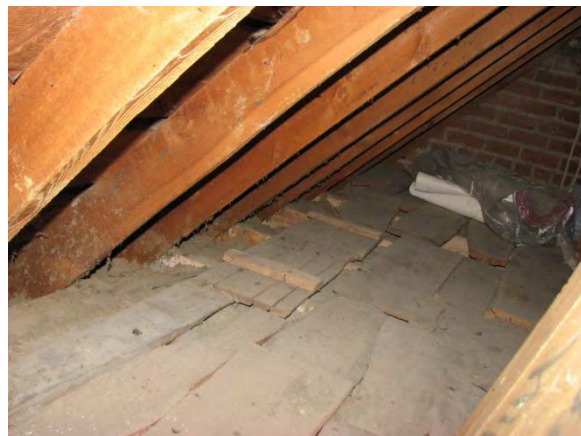
Attic trusses in Bonner House (Packer, 2010).

The overall condition of the Home's roof and floor system appears to be in good condition when considering the age of the structure and the environment in which it has been exposed to.

Observation indicates that the roof and floor framing shows no significant signs of failure or distress. However, due to the age of construction, it's anticipated that some damaged framing will be uncovered with further observations.

Any damaged roof and floor framing should be repaired or replaced. It's recommended that the roof shingles be removed from each structure and the roofs sheathed with ½" sheathing

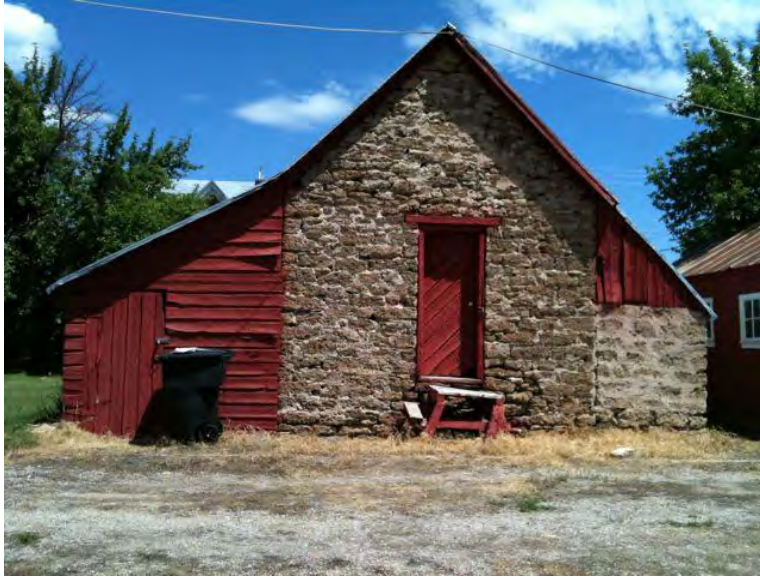
The Granary's roof and floor system appeared to be in satisfactory to poor condition. Much of the roof and floor framing is damaged and will need to be repaired or replaced. A mid bearing beam line had been installed later on in order to stiffen the floor joists. However, this beam line needs to be repaired or rebuilt. The siding on the west side addition is also in poor shape and needs to be replaced. See photo on following page.

Granary west elevation. (Packer, 2010).

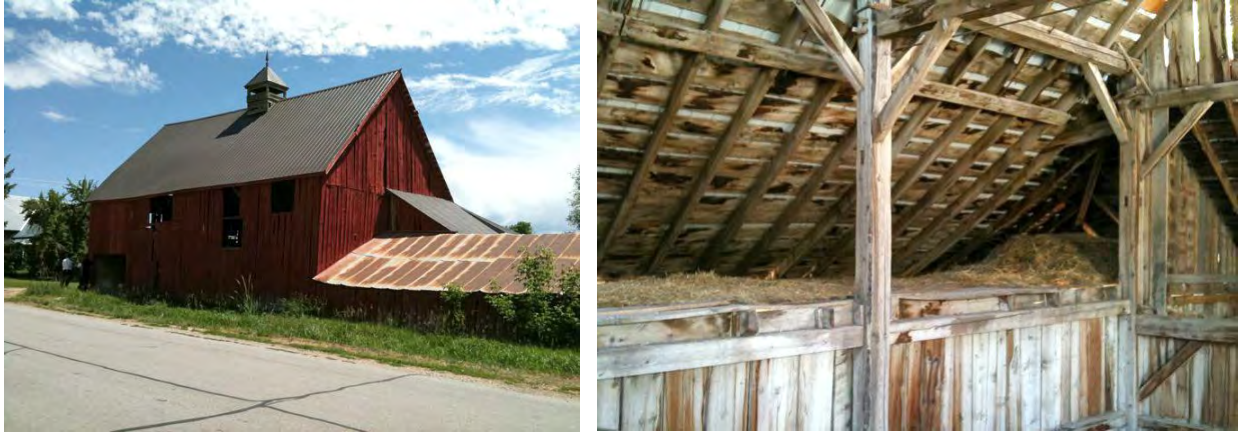
Barn, exterior view and interior showing post-and-beam structure. (Packer, 2010).

The condition of the large Barn appeared to be poor especially at its southern addition. It was observed in several areas that the post and beam connections have either failed or partially failed.

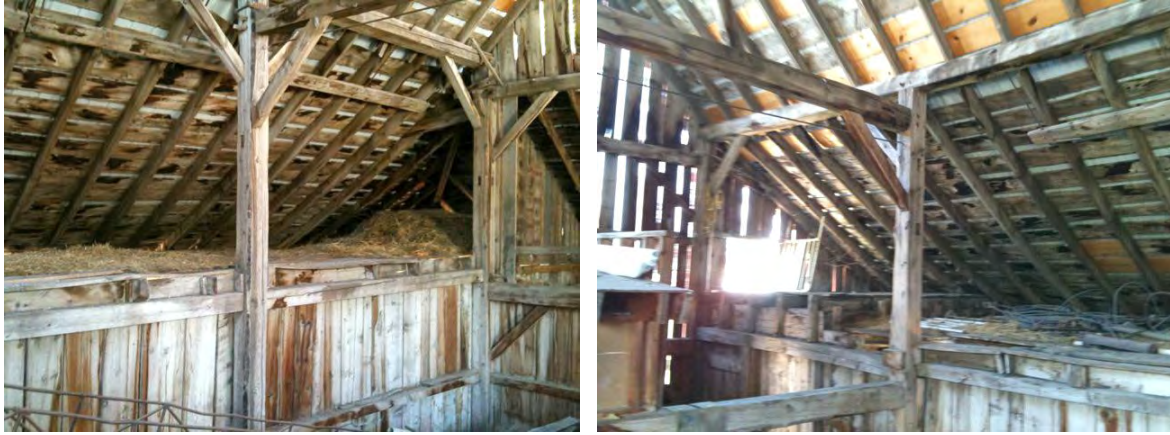
At some point in time, steel tie rods were installed to help tie/hold the original barn structure from side to side in order to resist bowing of the structure. The steel rods can be seen in the photos on the following page. The upper level floor and roof of the East addition has pulled away from its supporting beams and has been inadequately modified to try and keep the floor system in place.

Interior photos of barn, showing steel tension rods. (Packer, 2010).

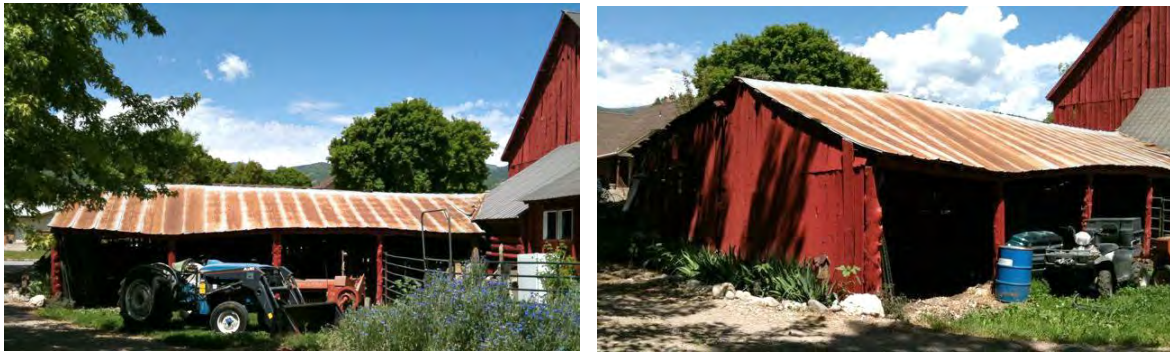
The Southern addition has also racked and many of the beams and columns appear undersized. See photo below.

South barn addition. (Packer, 2010).
