HISTORIC STRUCTURE ASSESSMENT

HOUGH BUILDING CORNER OF THIRD AND SILVER STREETS LAKE CITY, COLORADO

PREPARED BY
MARK M. JONES ASSOCIATES, ARCHITECTS, LLC
1085 GRAND AVENUE
DEL NORTE, COLORADO 81132
(719) 657-2070 FAX (719) 657-2072

HISTORIC STRUCTURE ASSESSMENT
State Historical Fund Project #2003-HA-068
June, 2004

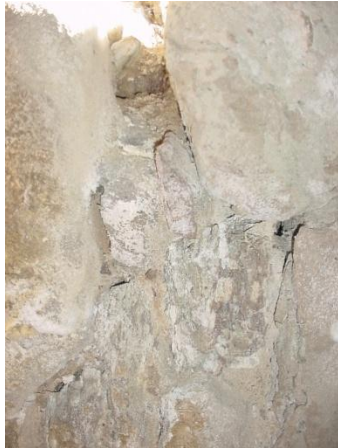
The foundations range between fair and good condition, and are sturdily holding the building in place. The integrity of the stone wall system is fair, having been damaged over time by significant water erosion. The water erosion has occurred at the west and south stone foundation walls. The later installation of sidewalks on the west and south elevation has apparently halted further erosion of the foundation elements at these locations.

The area at the southeast corner is in poor condition. When this portion was jacked up, the workers were overly exuberant. They jacked the corner of the building up nearly two courses of brick too high. The jacking at this point caused the building to fail at and around its natural weak points at the easterly window and central window of the east wall. This has impacted the masonry walls and has set the window at the southeast corner askew. This window is no longer open to the inside. Instead the opening is infilled with concrete block. No leaks are apparent at the foundation, so apparently foundation drainage is not a problem.

Left: *Eroded area at south stone foundation wall.*

For nearly the entire building perimeter, and the central demising foundation wall between building 1 and building 2, the foundations require no corrective work. The west and south foundation walls should be monitored for evidence of further erosion.

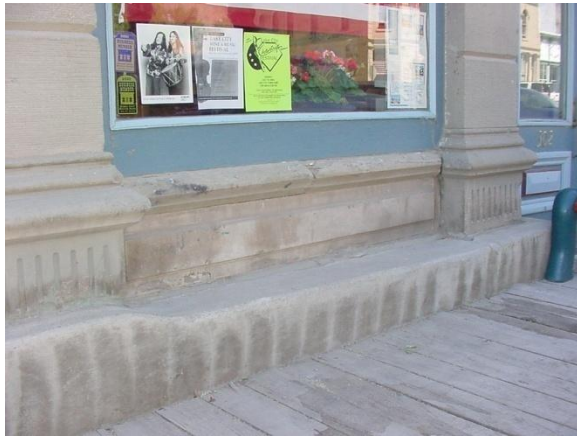
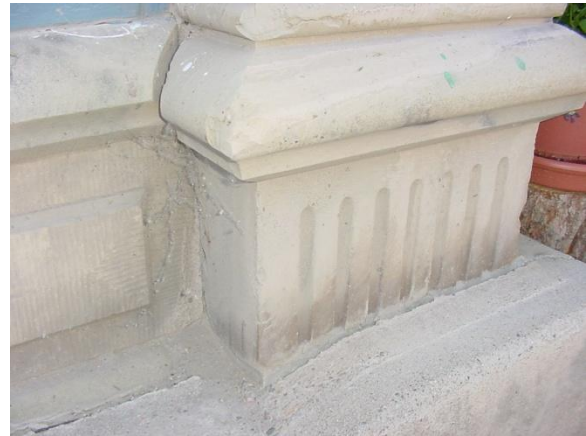
The concrete lower level slab appears to be in good condition. The only element of poor construction is the concrete curbs for the stone base on the west elevation of building 2. These curbs were an unnecessary addition, and hide the historic profile of the base.

West elevation of building 2 with concrete curb at stone base. Detail at concrete curb.

The concrete curbs should be removed carefully with hand tools, with care not to damage the original stone base. Once the bases are thoroughly clear of any concrete, they should be carefully cleaned with an approved restoration cleaner. Depending on the condition of the stone bases once the concrete has been removed, these may need to be replaced.

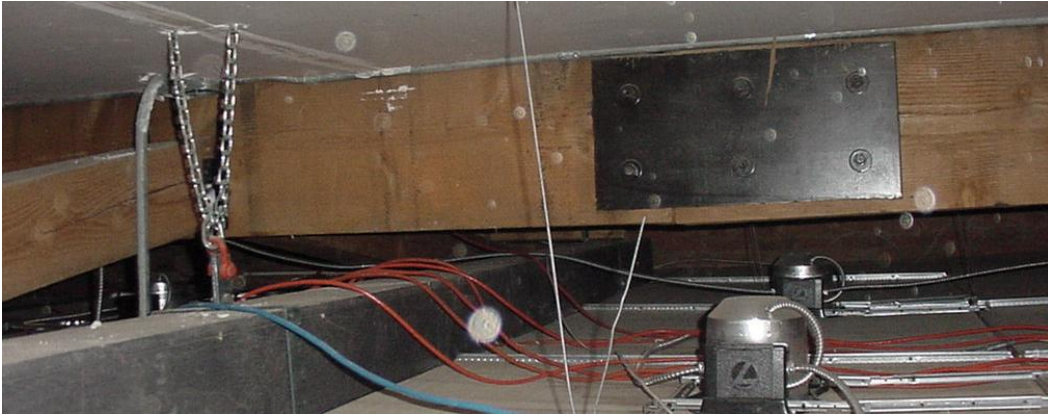
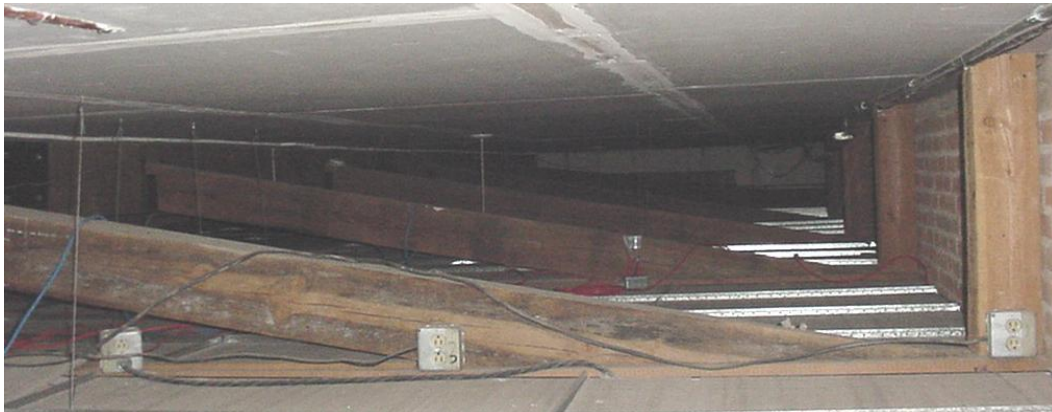
Above: *Structural retrofit showing central beam, strut and horizontal member.*

Below: *Structural retrofit, showing strut and vertical column.*

The second floor structural system in building 2 encounters slightly shorter spans, and is in good condition. The second floor structural system in building 1 is in poor to fair condition. The floor joists have deflected several inches. The retrofit supports are of no value.

The second floor structural system in building 2 requires no modifications. The second floor structural system in building 1 needs to be addressed. First non-original elements including the timber columns, the horizontal members, and the diagonal struts should be removed. The central timber beam should be kept in place. This beam should be shored until the floor joists above it are approximately level.

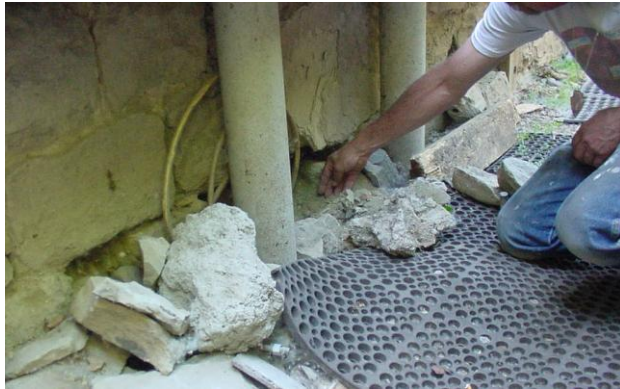
Left: Crumbling stone masonry at base of northwest corner of building 2.

The majority of the north stone wall does not require any structural work or retooling of joints. The exception is stone masonry at the northwest corner, which is crumbling. A portion of this stonework should be removed with new material replaced in kind.

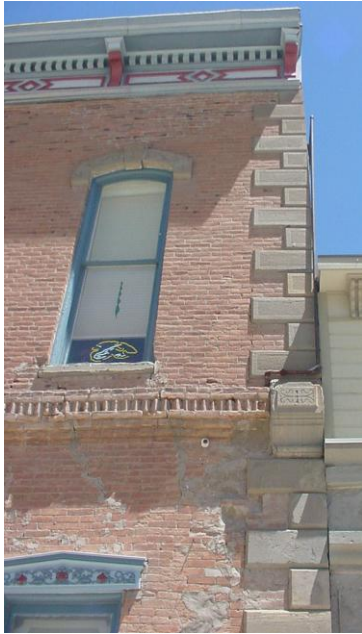
Upper level corner.

Photos of damaged areas of southeast corner of Hough Building:

Based on the factors previously mentioned: structural stabilization, historical accuracy, and cost effectiveness; the second option is recommended. This recommendation would offer greater structural stability, a historically accurate appearance, and less overall structural intervention, all for a lower total cost. During the course of the preparation of architectural and structural

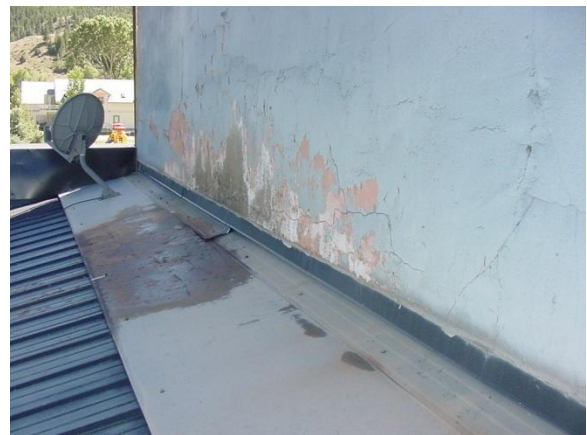
The rubber roofing system appears to be in good condition. All seams are intact and parapet flashing appears to be in good condition. The building maintenance worker, Mr. Charlie Curtis, reports that since this roofing system has been installed, no leaks have been reported. No signs of leakage were apparent on the second level, directly below this roof. The metal seamed roofing system appears to be in fair condition. The sheet metal flashing at the building edge is intact, but some has begun to rust from exposure to the elements.

Sheet metal flashing.

The roof should be monitored for any signs of leakage. No roof replacement is recommended at this time. Approximately ten linear feet of sheet metal flashing at the wall-roof intersection should be removed and replaced.

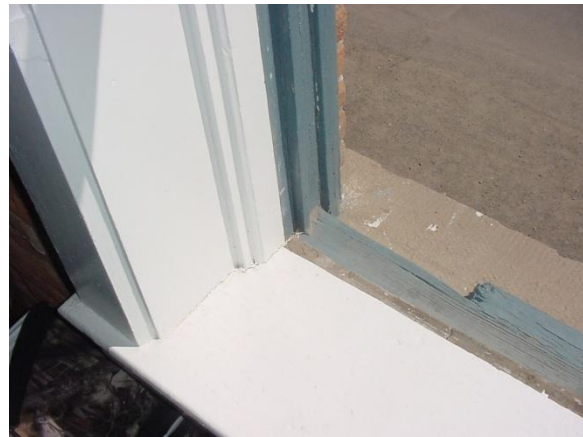
Upper level window: damaged wood trim.

Windows are all original, and appear to mostly contain their original glazing. Windows generally range from poor to good condition. Most of the windows have been well maintained and painted at the interior, but allowed to succumb to dry rot at the exterior, as depicted above. Paint on the interior of the windows is generally in poor to fair condition, and paint on the exterior of the windows is nearly universally in poor condition.

Determine through laboratory spectrographic analysis whether windows and trim were originally painted or stained, and if painted, what color. Refurbish windows as follows: Using gentlest means possible, remove all chipped and peeled paint from sash and frames only down to the next good paintable surface. Use epoxy filler to patch any damaged areas. Remove cracked glazing putty and re-putty. Prime the sash and frames. Use epoxy filler on cracked sills as needed.

Follow lead paint protocol. In all double-hung windows, replace all ropes and reset or replace any missing weights. Install new copper weather-stripping. Check all sash for proper operation. Replace any cracked panes with panes fabricated to match existing glass. Check inside finish. As appropriate to the original window treatment, reseal with paint or low sheen poly on any worn areas. Paint should be a close approximate of the original window color. Apply a poly finish coat. As an alternate, traditional varnish can be used, but would not be as durable as a poly finish.

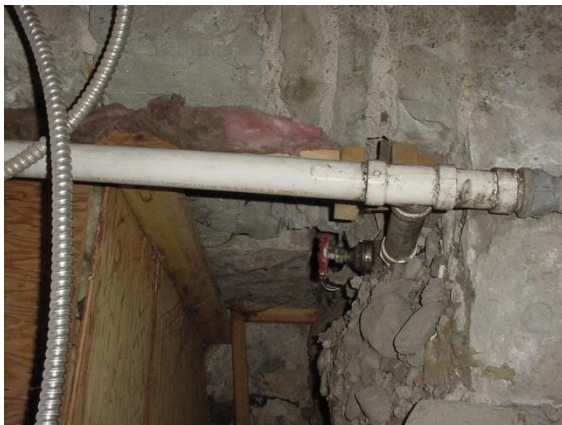
Above: *Domestic water service entry.*
Right: *Lower level pump station.*

The water service should be replaced with a 2" type AK copper pipe. At the time of the replacement, consideration should be given to the installation of a larger 4" service which would allow the building to be fire sprinkled in the future

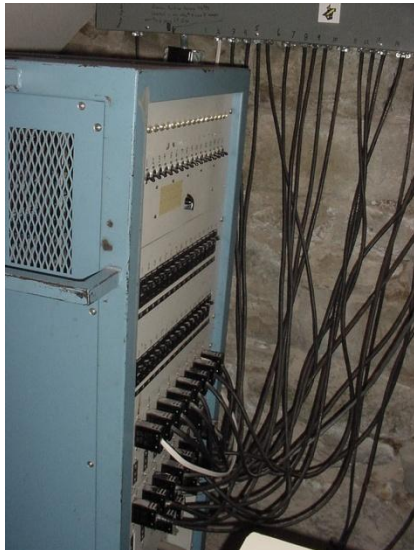
The installation of the electrical service entry is adequate and serviceable. However, it appears to be at its limit from a capacity standpoint. Additional power is not available for either the theater or any other future tenant. In addition, given the proximity of the service entrance to the outdoor dining area of the restaurant, it would be desirable to improve the appearance of the installation.

Left: *Theatre load center, currently in men's dressing room.*
