HISTORIC STRUCTURE ASSESSMENT

**SAINT THOMAS THE APOSTLE EPISCOPAL CHURCH
ALAMOSA, COLORADO**

ST. THOMAS THE APOSTLE EPISCOPAL CHURCH
607 4th STREET
ALAMOSA, COLORADO

HISTORIC STRUCTURE ASSESSMENT
State Historical Fund Project # 2003-HA-052
June, 2003

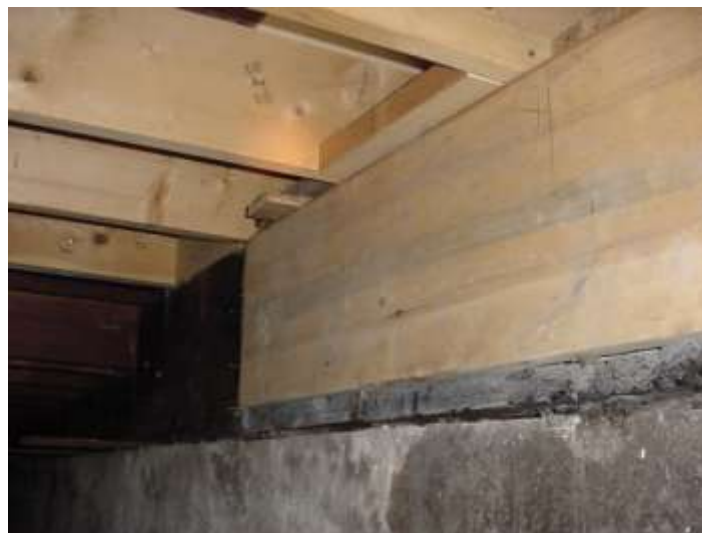
First floor framing consists of 2x8 members @ 16" on center spanning east-west, with 2x8 bridging. Below the chancel, or altar area, 2x12s rest several members wide upon a partially fire-damaged sill plate. 2x8 joists rest atop these 2x12s, spanning east-west.

Floor framing at chancel.

No corrective work is recommended.

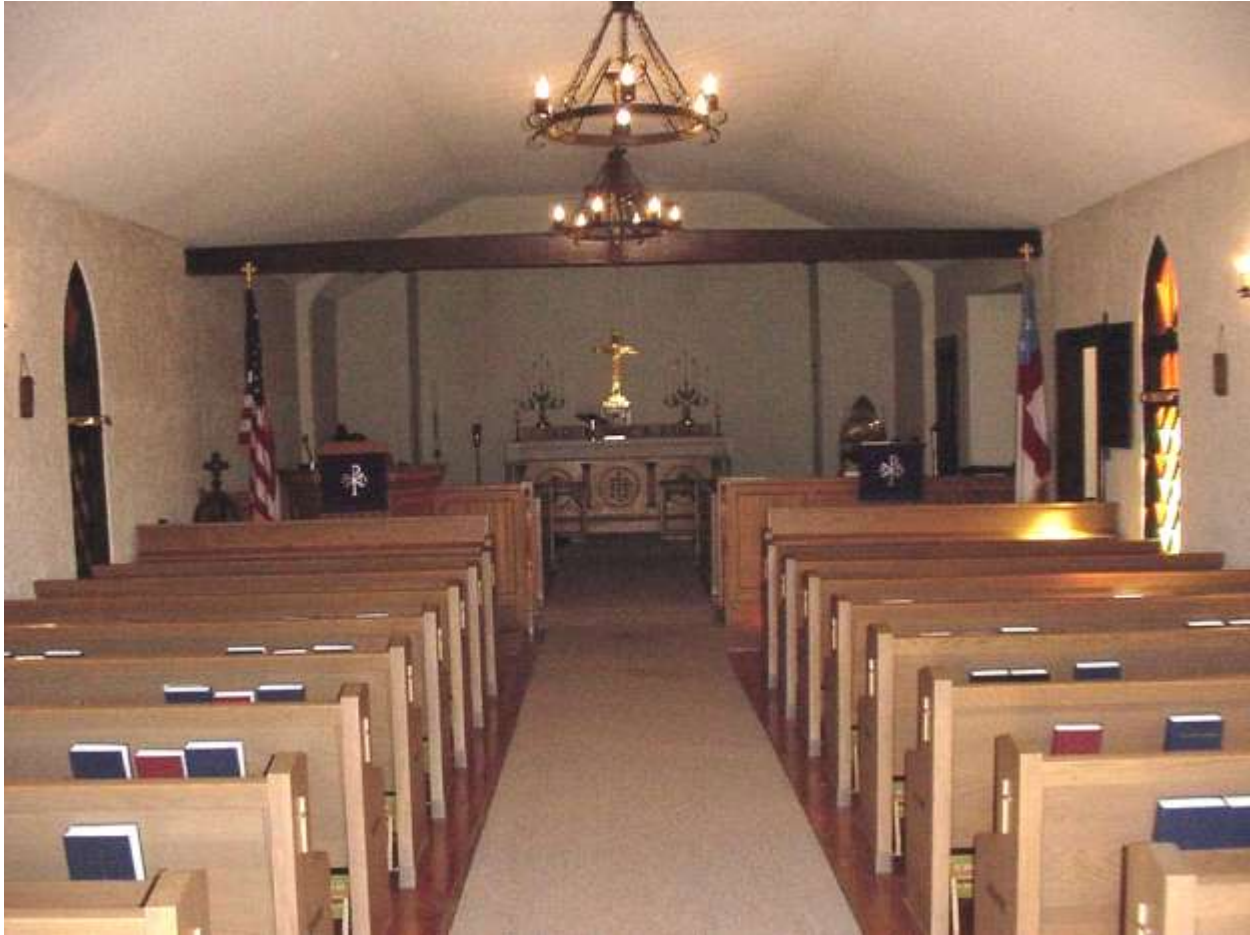
DESCRIPTION: A beam which in all appearances seems meant as a structural tension tie occurs in the Sanctuary. This is a false beam consisting of 2x members adhered to the side walls of the Sanctuary and has no structural value whatsoever.

Interior of Sanctuary, with false beam above step to choir area

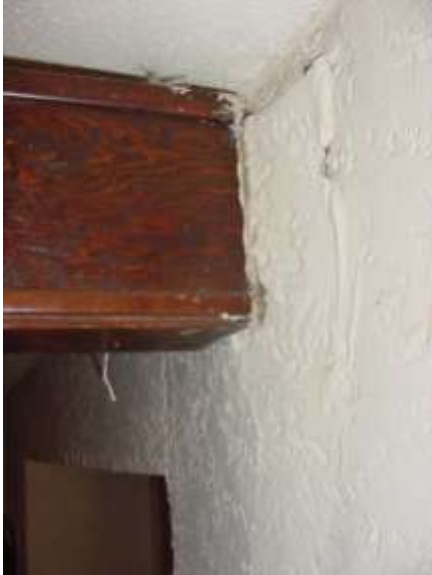
A close-up view of the Sanctuary decorative false beam. The beam does not bear on the Sanctuary side wall. Rather, it is merely toe-nailed to the structure. A look beneath the plaster revealed 2x blocking and celotex-type insulation board.

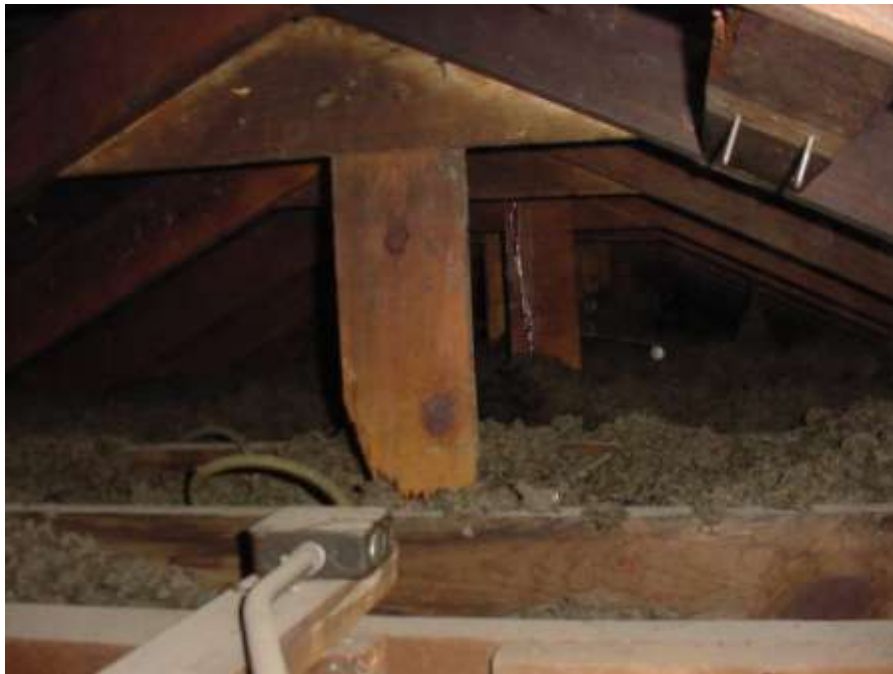
Sanctuary 2x6 field-assembled trusses, with various wood bridging and truss plates.

nominal. Based on this data, it is advised that the trusses should be removed and replaced. A number of the existing trusses, especially those over the north side of the chancel and the sacristy, may be able to be saved. During demolition of the Sanctuary ceiling these should be evaluated for their structural condition.

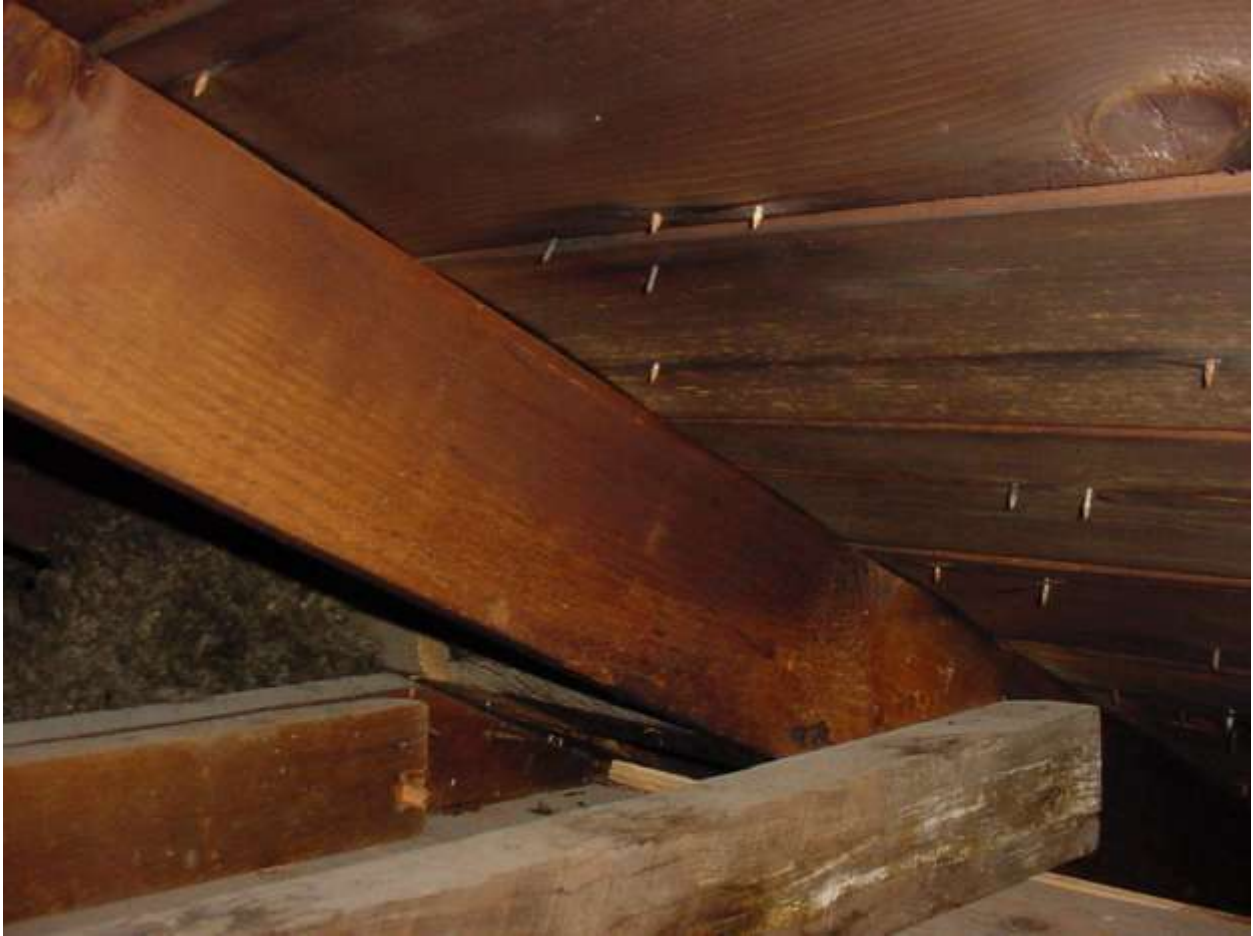
Sanctuary attic condition, showing field assembled truss.

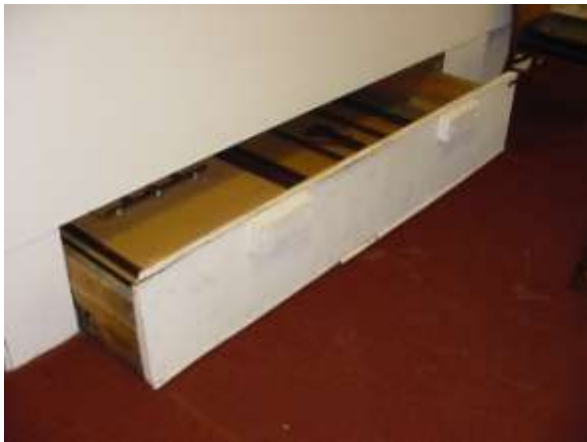
At left: Parish Hall stage drawer system.

The drawers should be completely removed, repaired, and put back into place in good working order. Any projections should be removed, and all moving parts and wheels should be inspected. At the very least, all elements should be lubricated, and any defective parts should be replaced. Consideration at this time should be given to installing motorized drawer openers, similar to motorized garage door openers.

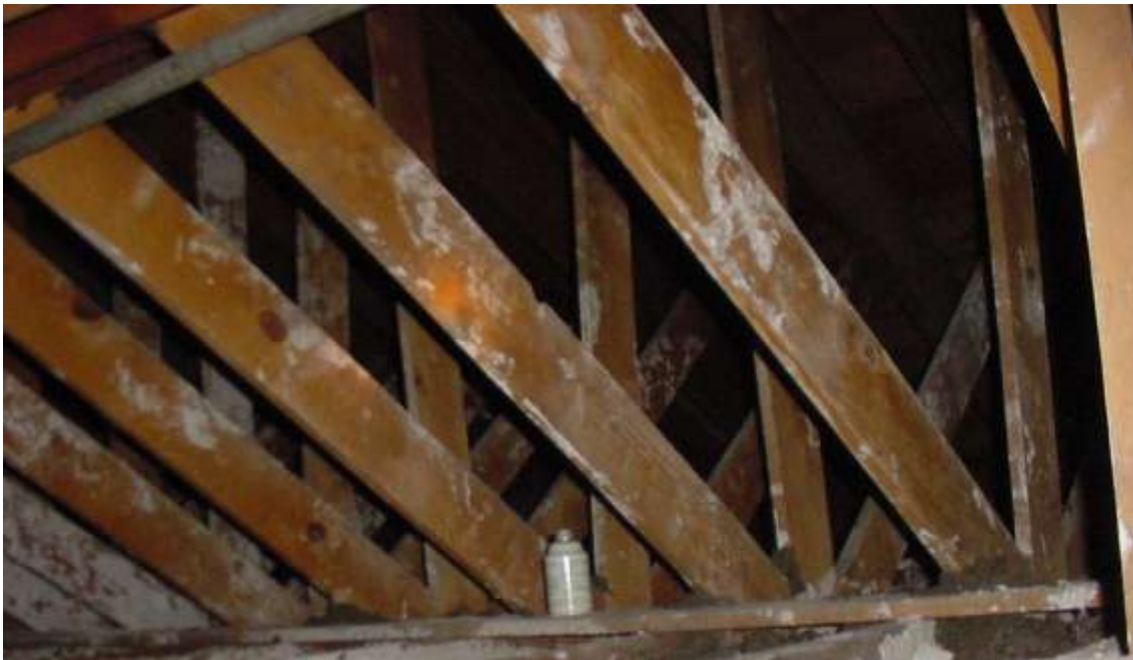
The roof trusses are in very solid, straight condition. All appear to be structurally sufficient for the weight of clay tile roofing. Apparently the wood that composes these trusses was used for concrete formwork. White powder still coats most of the members.

Roof trusses at Parish Hall.

The white plaster-like powder coating the members of the trusses should be analyzed in a laboratory to determine its content. If it contains no harmful substances, it should be simply left in place.

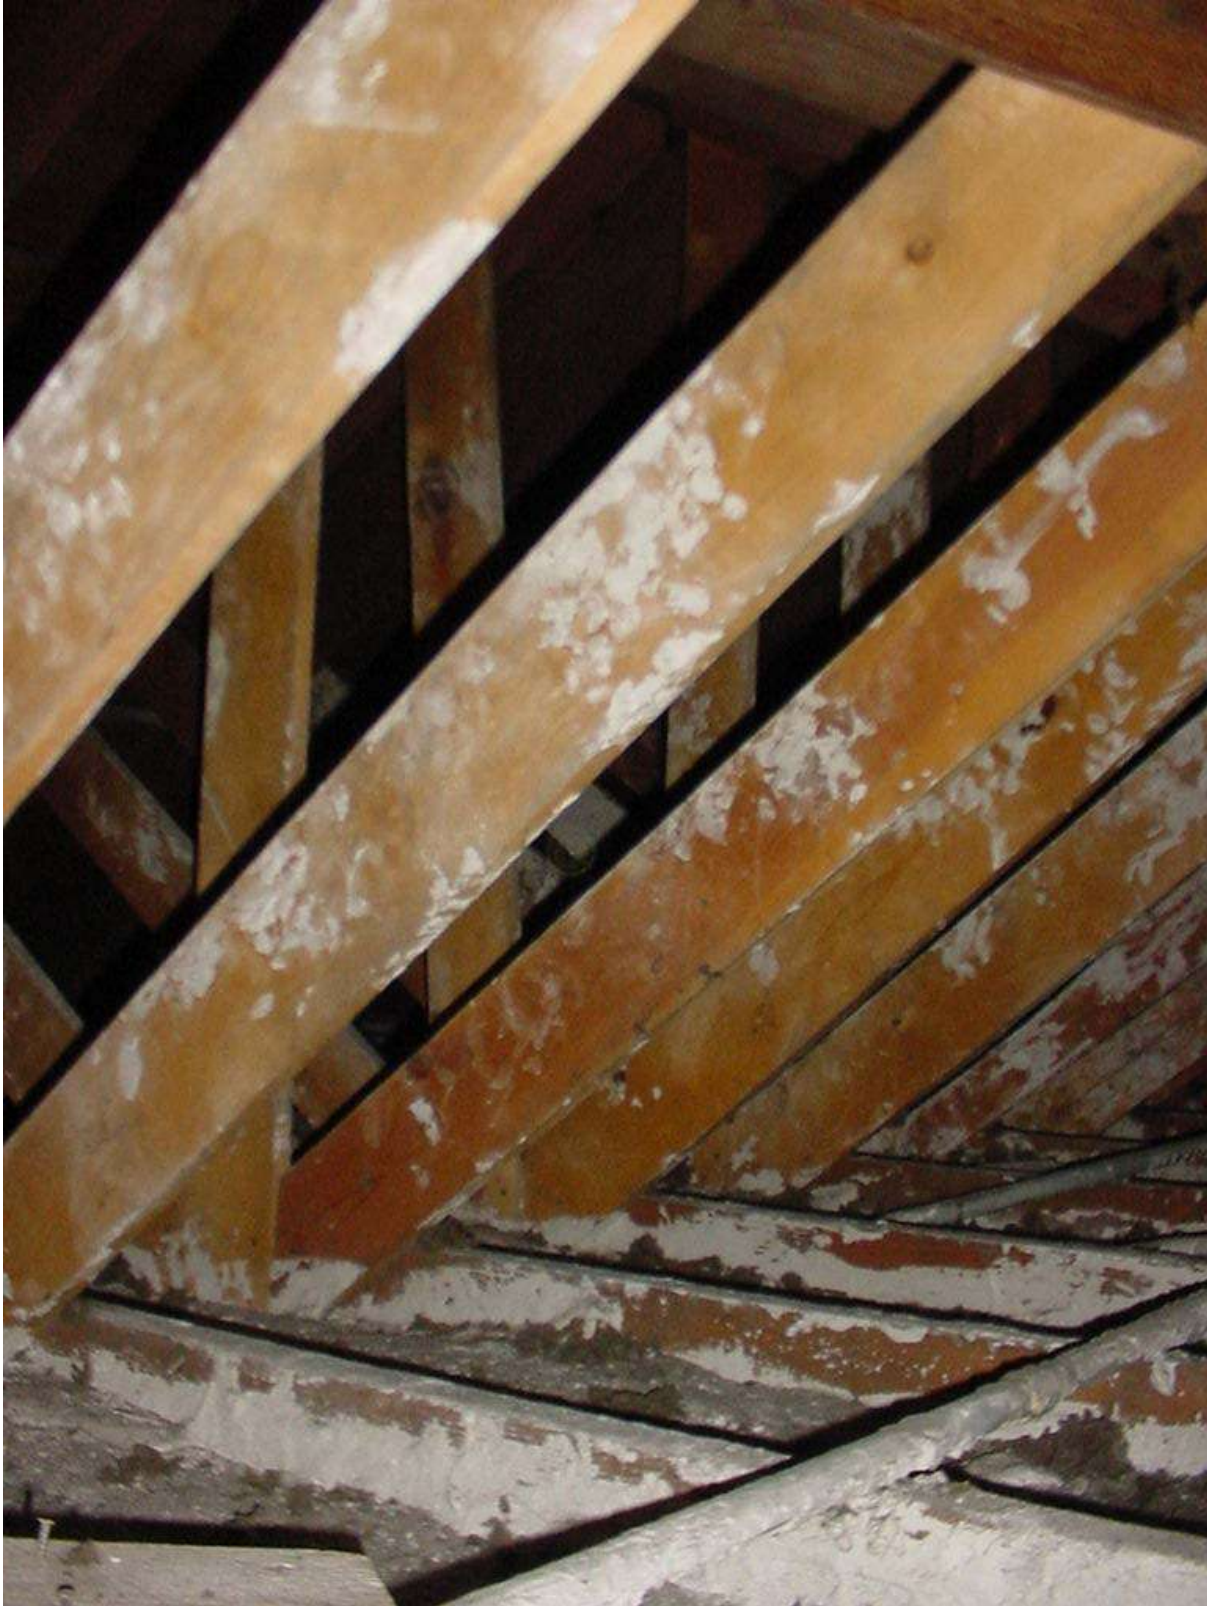
Roof trusses at Parish Hall. Note plaster-like powdery substance.

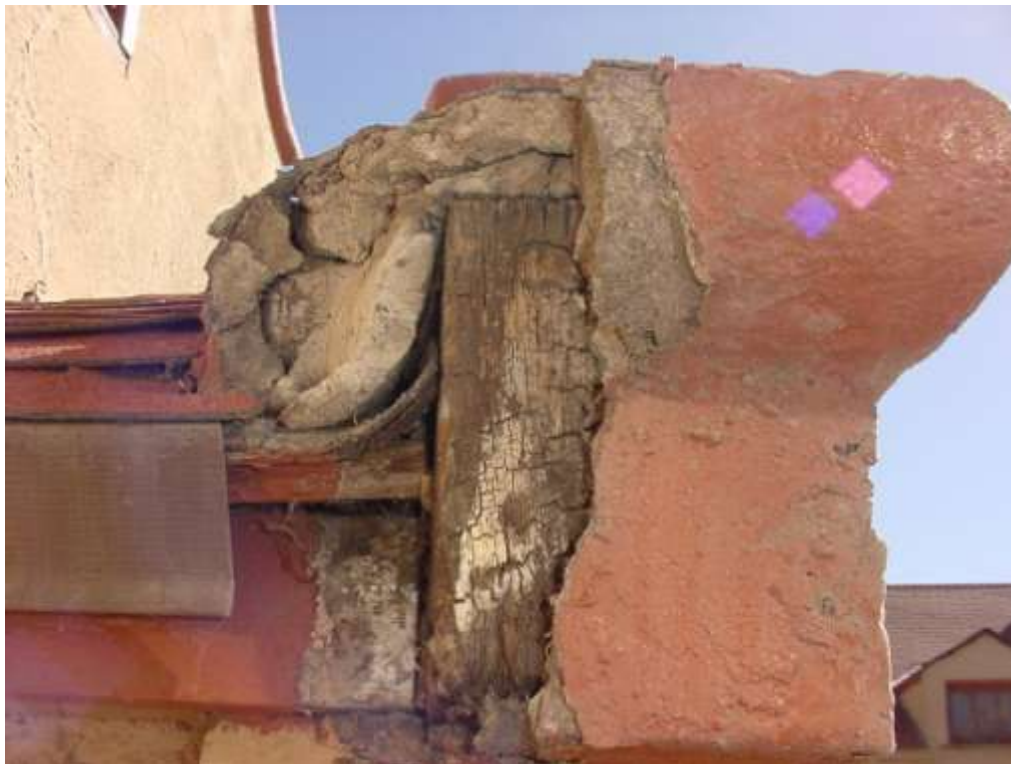
The paint is peeling off the stucco and is in poor condition. The exterior wood trim in some locations has deteriorated and rotted, and is in poor condition. The glazed clay trim is disintegrating at its edges, and is in poor condition. The ventilation grilles are operable and in good condition.

Wood rake boards and cement mortar trim at the west side of entry wall.

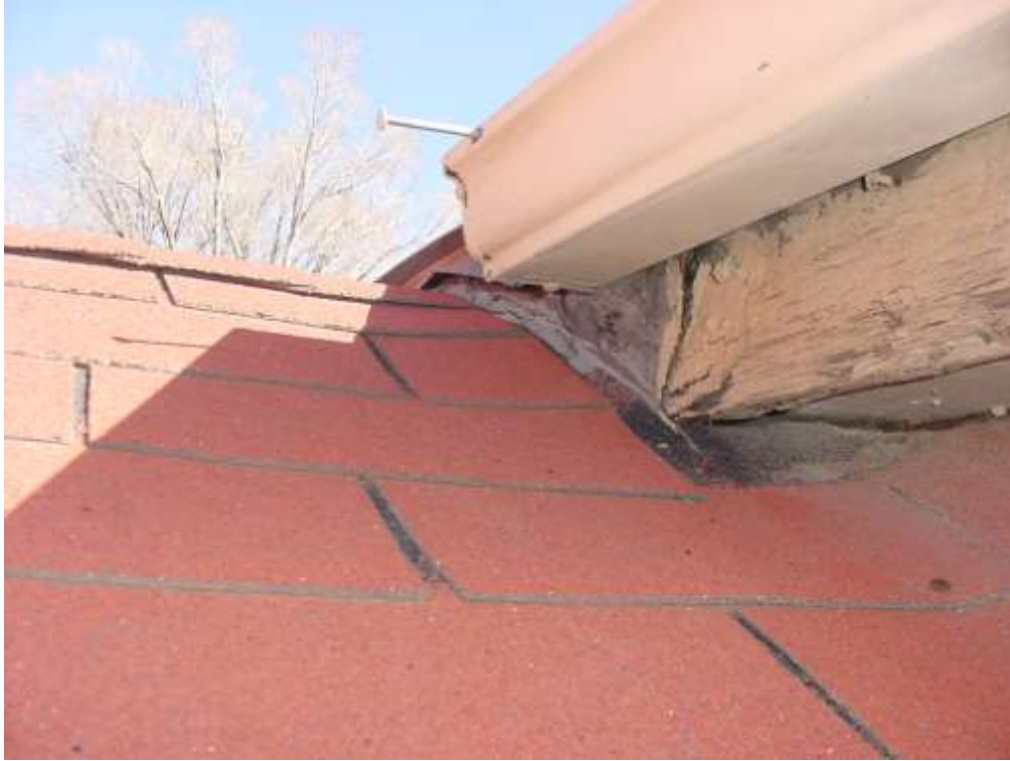
Wood trim at wall/ roof intersection at side Sanctuary entry.

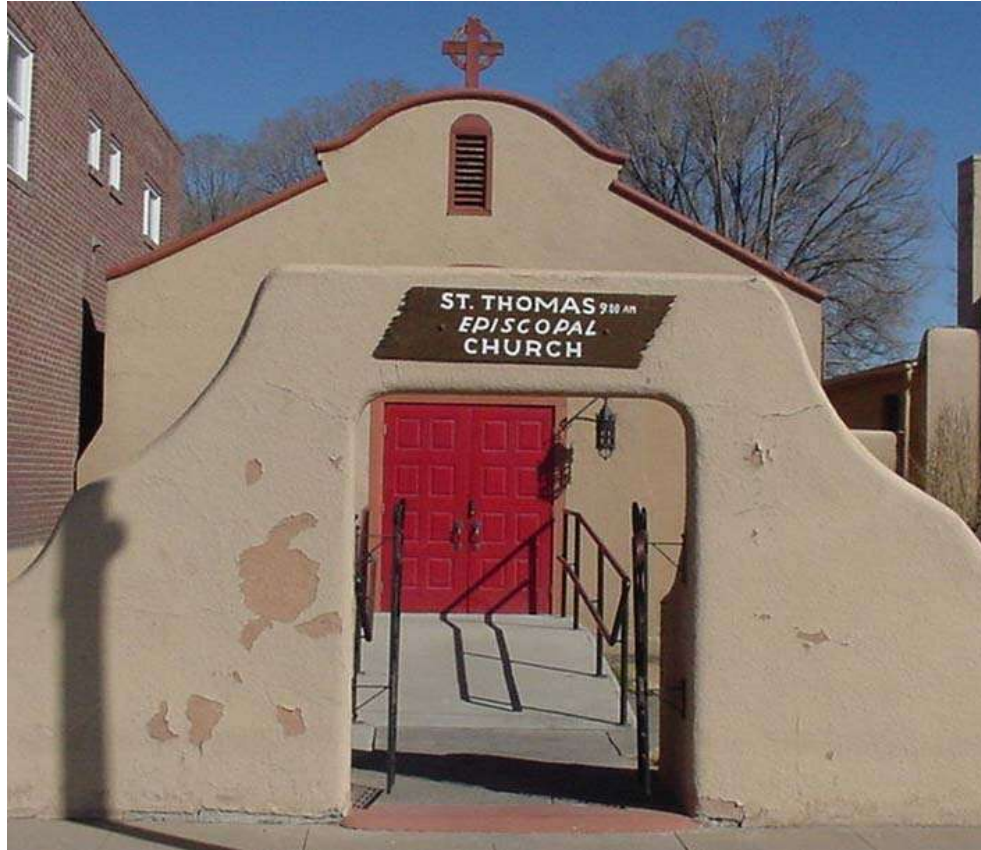
its apex. An additional 3” of rise occurs in the 10’-9” run between the ramp end and the sidewalk edge. The heights of the iron guardrails and handrails located on either side of the ramp are also not code compliant. The wall enclosing the church property is in fair condition, with minor holes and defects in the stucco application, and some peeling areas of paint. The iron gate and guardrails are in good condition.

Above: Ramp at Sanctuary Entry

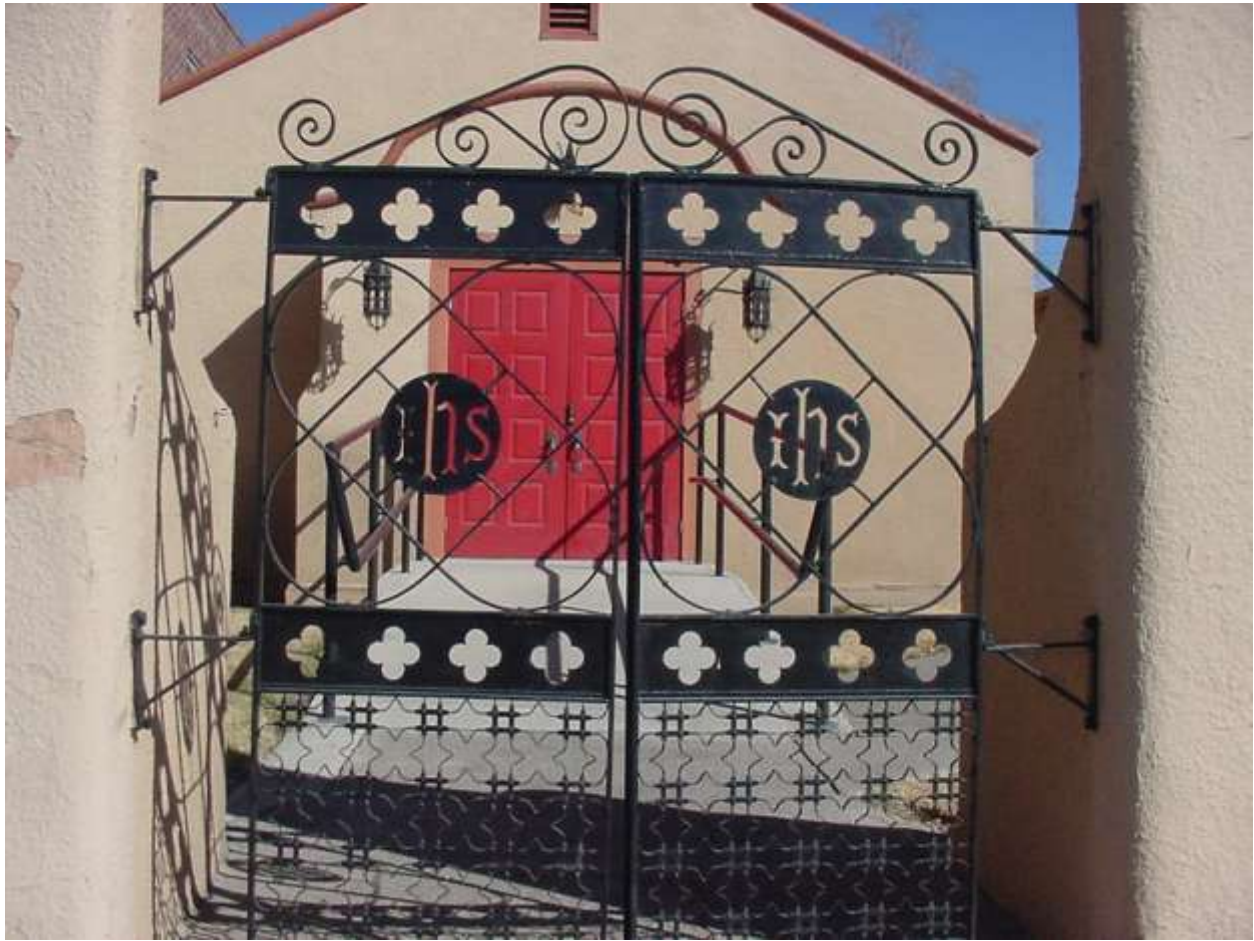
Iron gate at Sanctuary main entry.

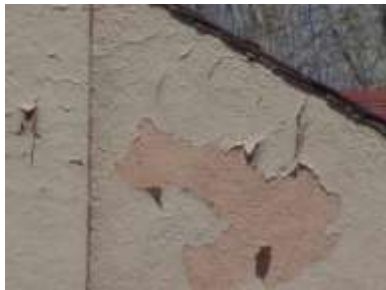
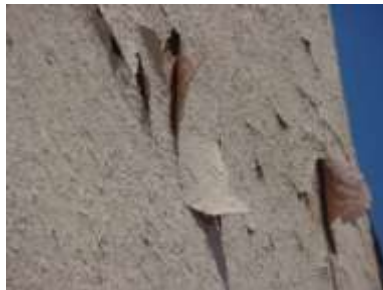
The paint covering the stucco is peeling badly, and is absent in some areas. Minor cracks appear in the surface of the stucco. The wood trim is in poor condition, due to weathering and decay in some locations. The glazed clay parapet edge is in good condition. The glazed tile frontispiece surround has several paint stains and eroded areas.

Peeling paint over stucco..

recommended for the glazed clay parapet edge. The glazed tile surround should be cleaned, and any abject tiles replaced to match. Grout for new tiles should match color and consistency of surrounding tiles. The original lanterns should be removed from the Sanctuary entry and installed in their original location at the Parish Hall entry. New lanterns should be fabricated for the Sanctuary, and should be exact replicas of the original Parish Hall pair.

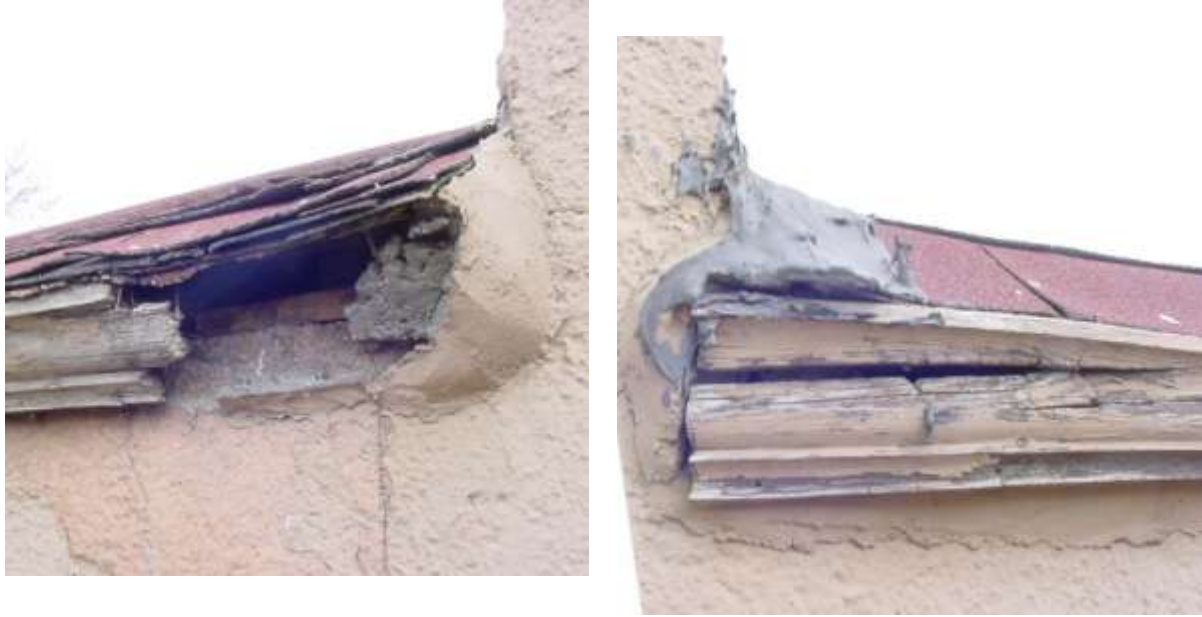
Deteriorated wood eave trim board in two locations at west wall of Parish Hall.

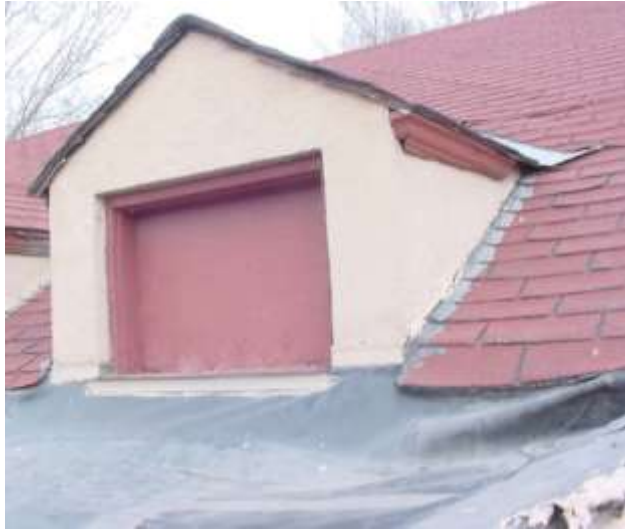
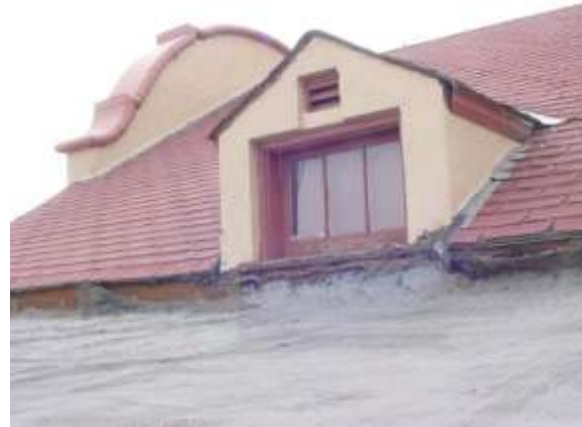
*Sealed dormer at west side of Parish Hall.
Dormer at east side of Parish Hall.*
