HISTORIC STRUCTURE REPORT

The William Bonner House

110 EAST MAIN STREET
MIDWAY, UTAH

FINAL DRAFT REPORT
OCTOBER 2012

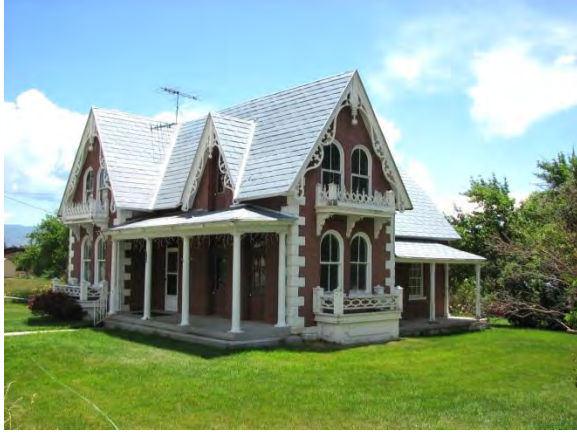
Original Home. (Packer, 2010).

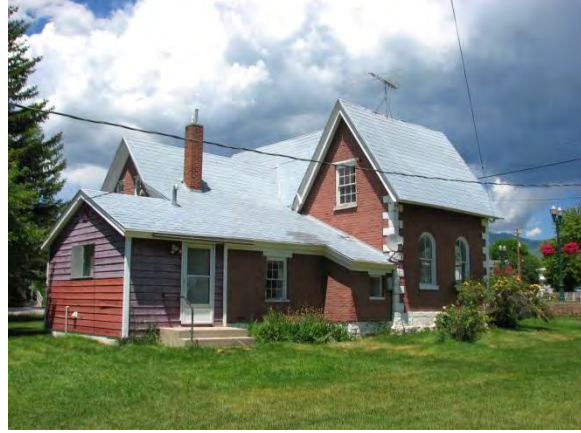
Home, showing additions (Packer, 2010).

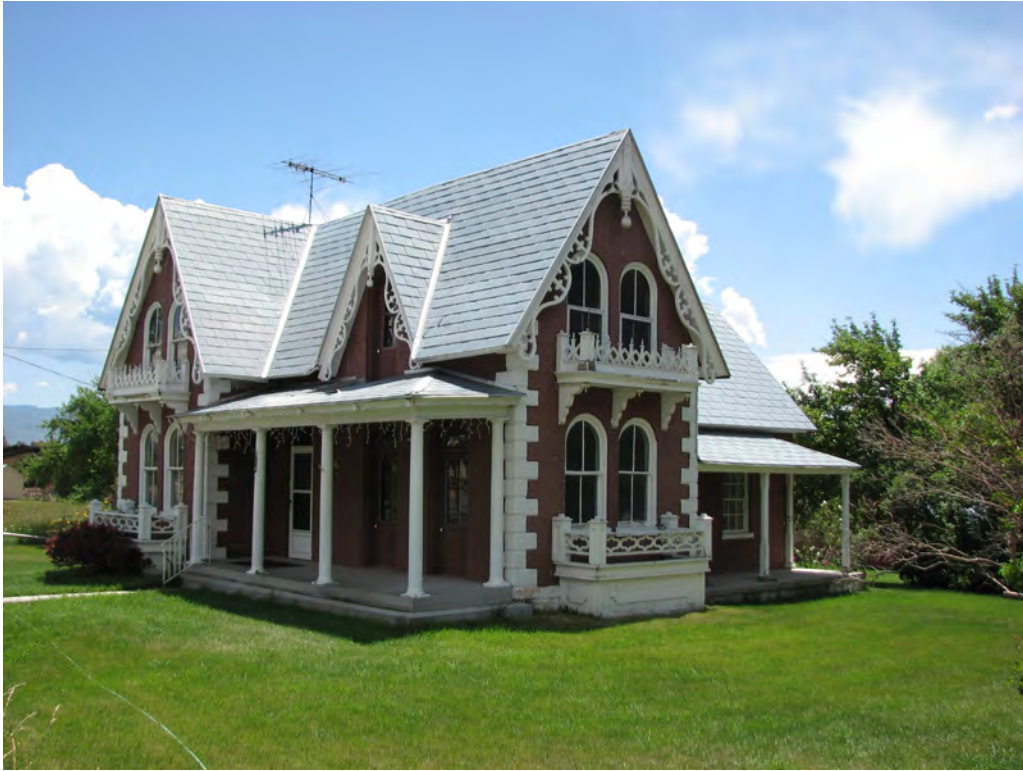
Photo 1

The William Bonner III House is a two story structure with a partial basement and crawl space located at 110 East and Main within the town of Midway, Utah. Also on site are several other ancillary structures. In addition to the home, there is also a large Barn, a Granary, a Garage and a couple other small structures. This report will focus on the Home. **See Appendix Photo 1.**

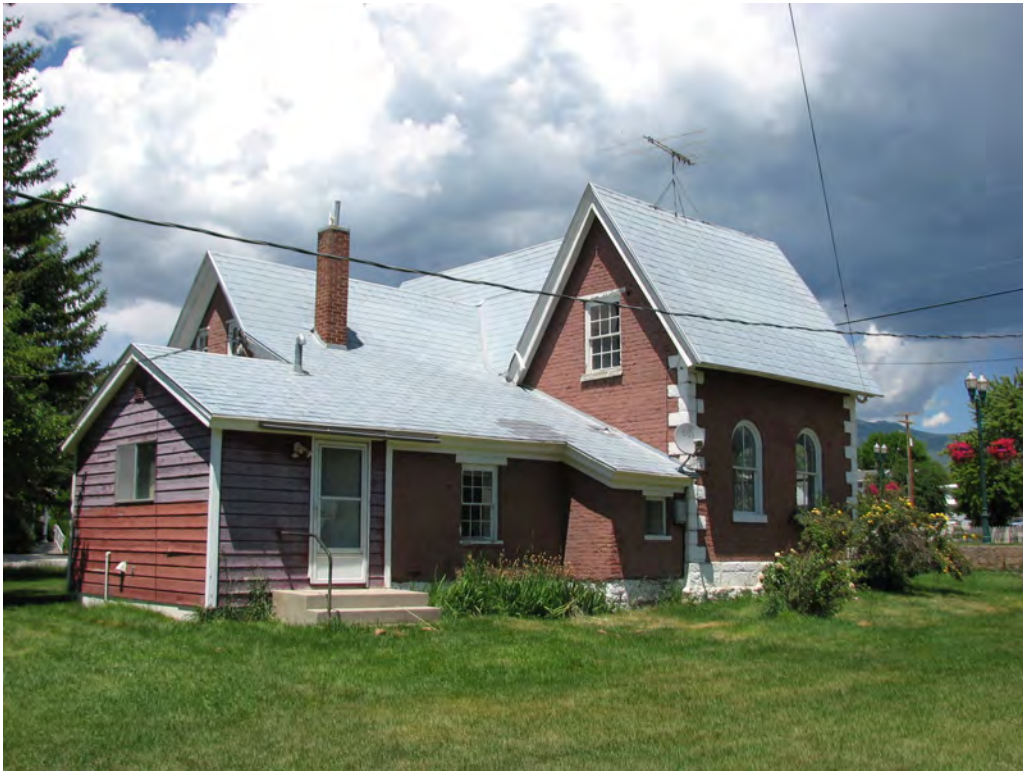
Photo 2

The original home was built around 1877. Two southern additions were provided later on to the original structure with the last addition being primarily wood framed. **See Appendix Photo 2.** The age of their construction is unknown at this time; however, the last addition appears to be less than 50 years old. The home is approximately 1900 SF in size and currently vacant, but it was mentioned that it was used for some time as a rental.

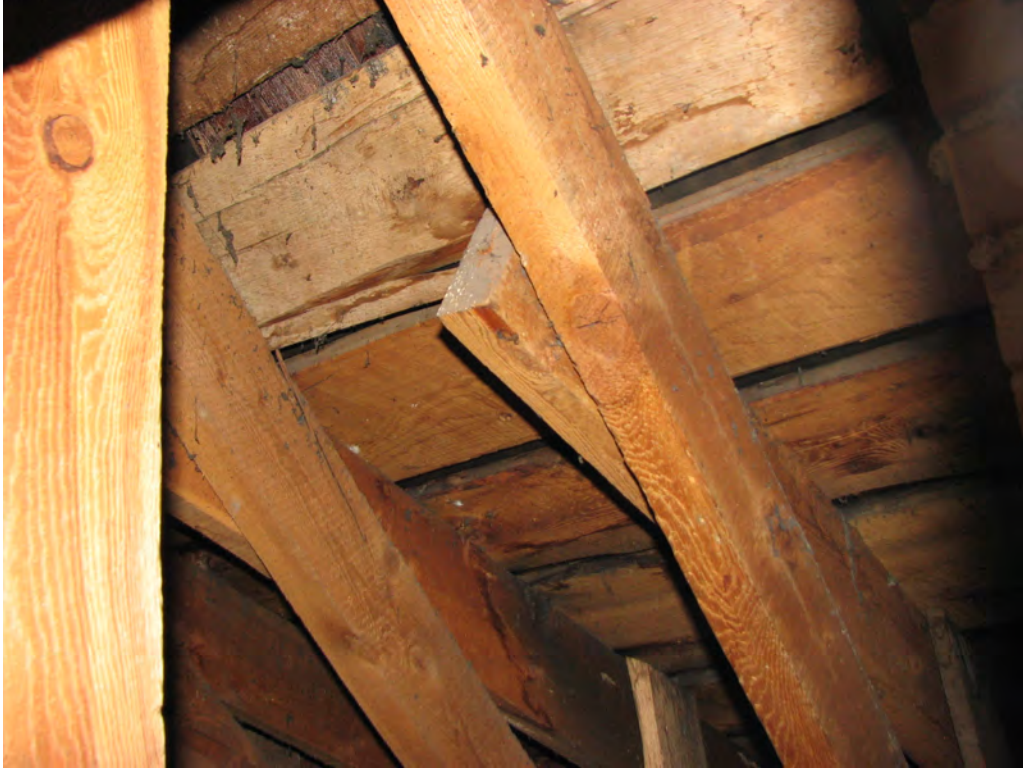
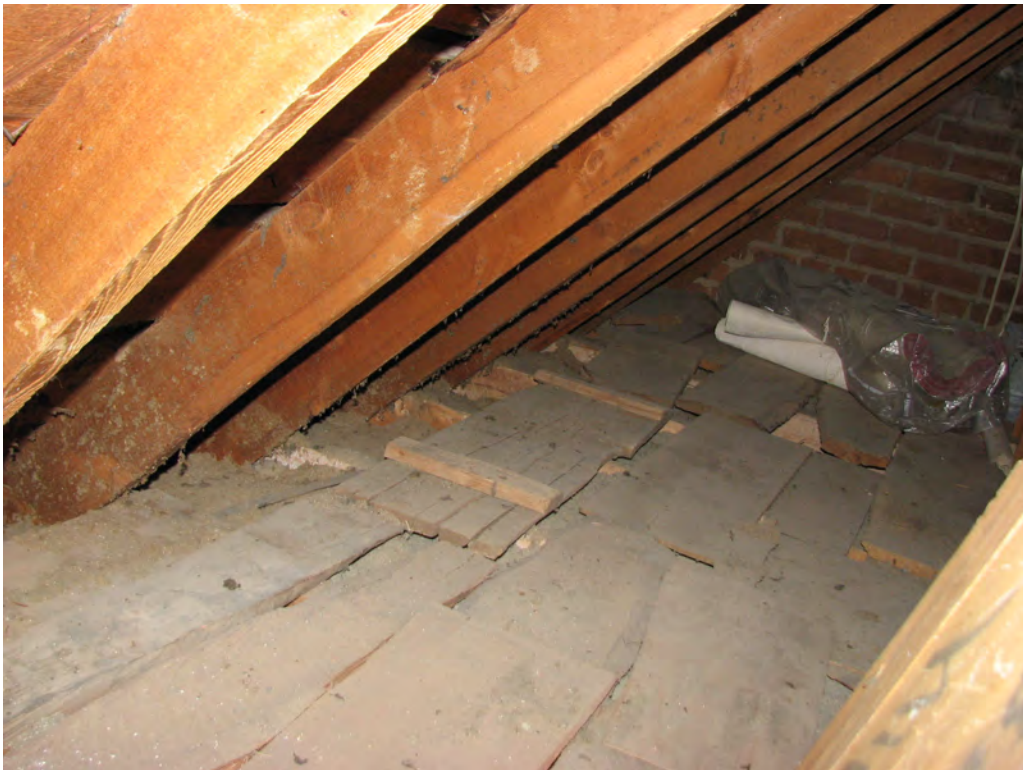
The roofs and floors are wood framed. The roof is wood framed with 2x6 rafters and collar ties and sheathed with 1x skip sheathing. **See Appendix Photos 3 and 4.** The upper and lower level floors are also wood framed with 2x6 and 2x8 joists respectively. The floors are sheathed with 1x decking.

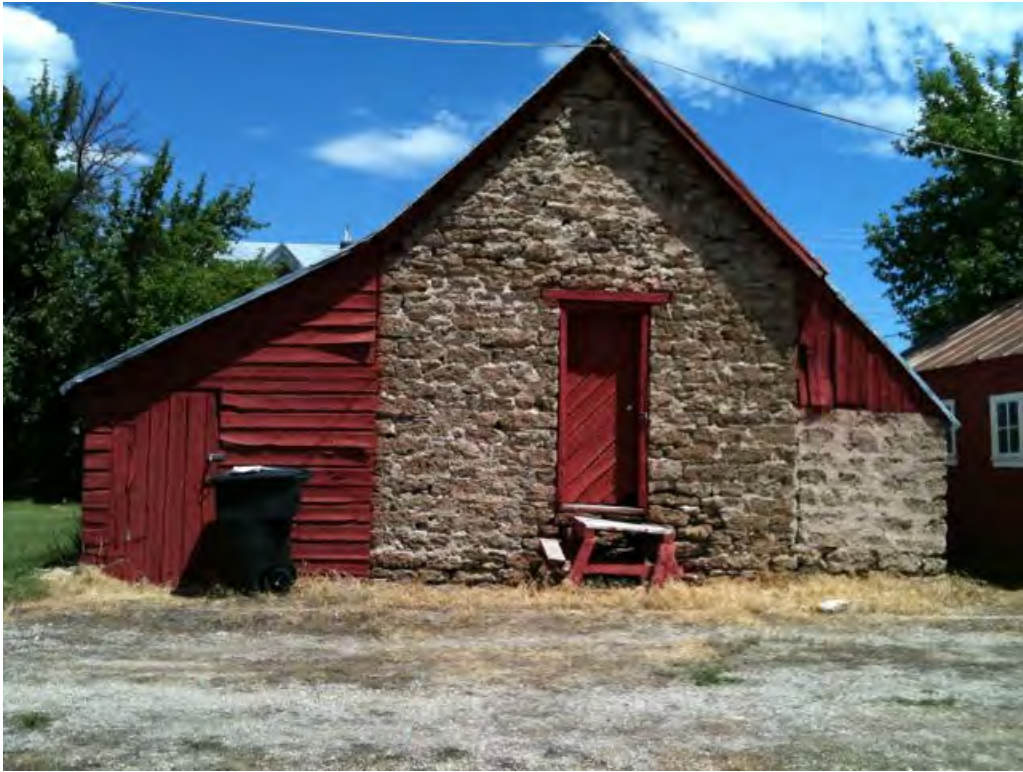
Photo 1

The William Bonner III Residence is located at 110 East and Main within the town of Midway, Utah. Also on site are several other ancillary structures. In addition to the home, there is also a large Barn, a Granary, a Garage and a couple other small structures. This report will focus on the Granary. **See Appendix Photos 1 and 2.**

The Granary's roof and floor system appeared to be in satisfactory to poor condition. Much of the roof and floor framing is damaged and will need to be repaired or replaced. A mid bearing beam line had been installed later on in order to stiffen the floor joists. However, this beam line needs to be repaired or rebuilt. The siding on the west side addition is also in poor shape and needs to be replaced. **See Appendix Photo 1.**

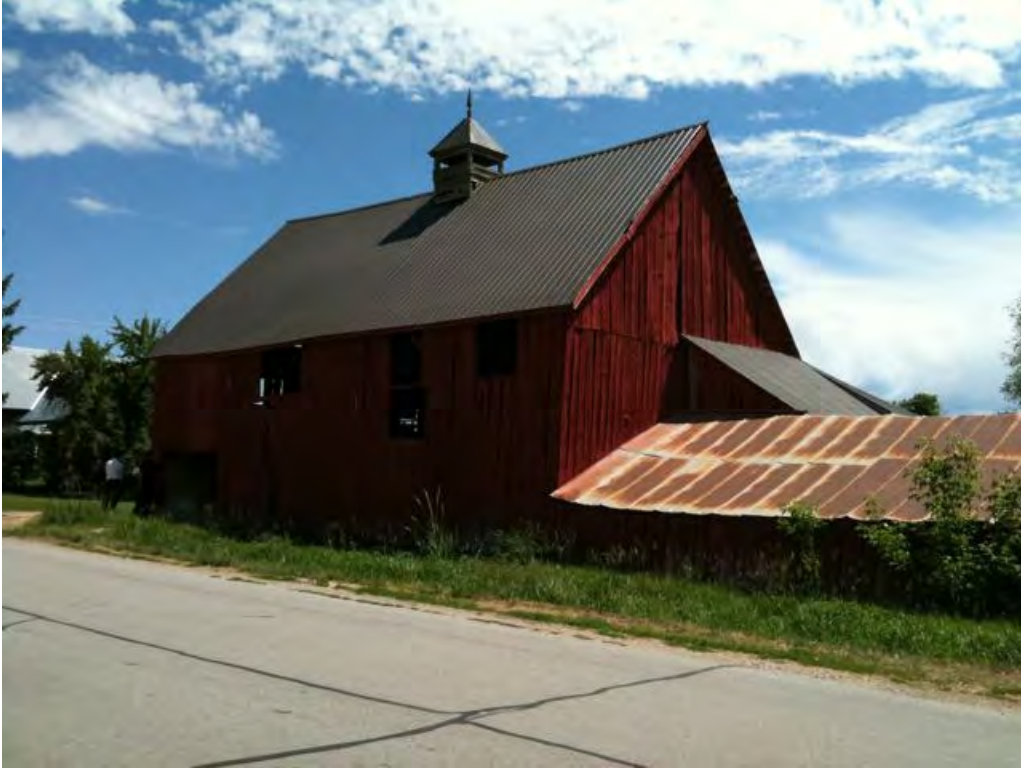
Photo 1

The William Bonner III site is located at 110 East and Main within the town of Midway, Utah. Also on site are several other ancillary structures. In addition to the home, there is also a large Barn, a Granary, a Garage and a couple other small structures. This report will focus on the Barn structure. **See Appendix Photos 1 and 3.**

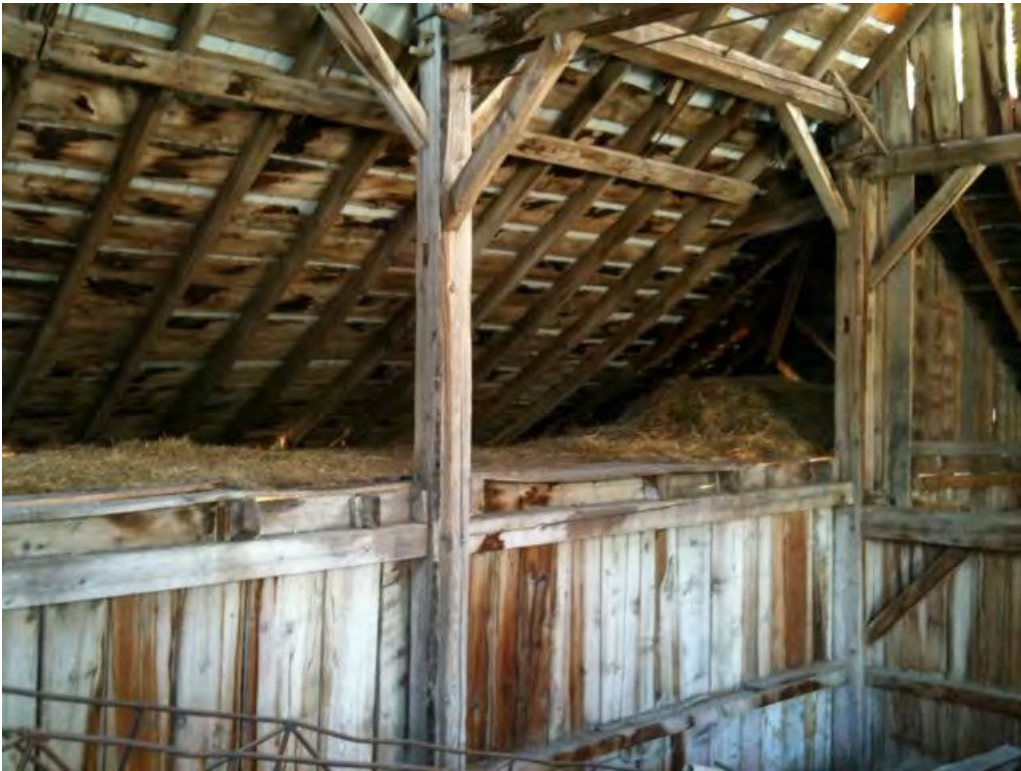
Photo 2

The Large Barn is a wood post and beam type structure. **See Appendix Photo 2.** Over time, a couple additions have been provided on to the original barn structure. **See Appendix Photos 3 and 4.** The south side garage addition is also framed with posts and beams but with stripped log type members. The east side addition is framed a bit differently in that the exterior is framed with stud walls. It's unknown at this time when the original barn was built along with its additions. The Barn currently is being used for miscellaneous storage space.

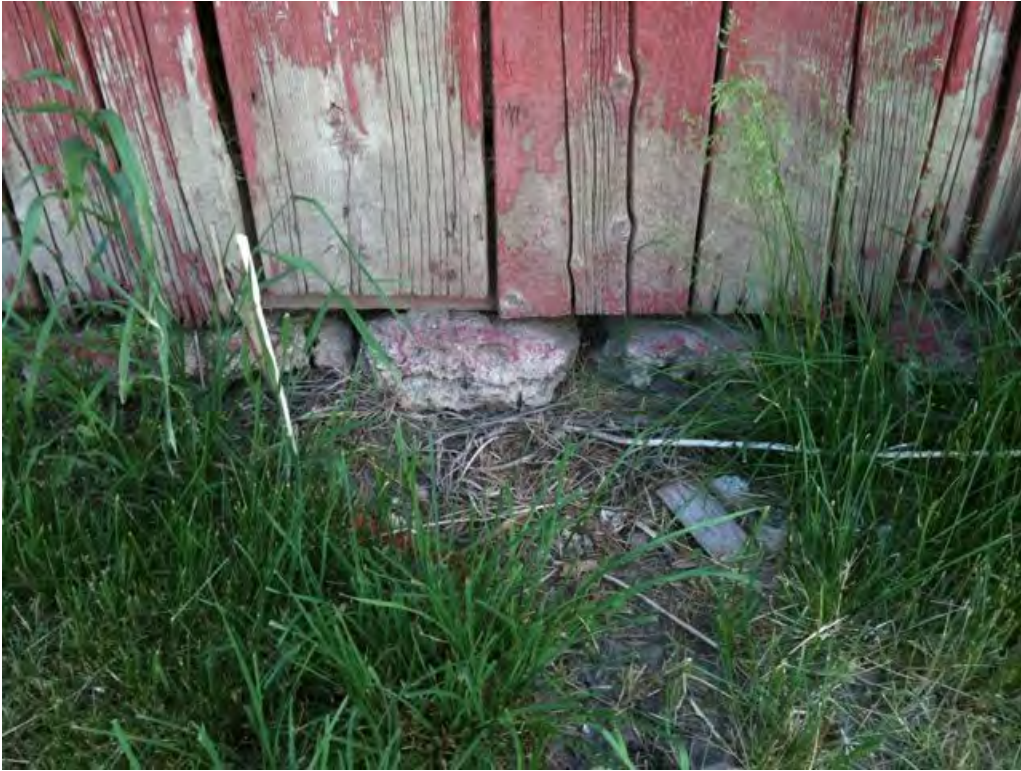
Photo 5

The structural system of the Barn is primarily supported by unreinforced volcanic limestone type masonry foundations. The limestone masonry is known locally as "Pot Rock". It was mentioned that the Pot Rock was quarried nearby and is used throughout the area for structural foundations and exterior wall systems. The Pot rock is typically light in color and filled with vesicles. Vesicles are small cavities or air pockets formed by the expansion of gas bubbles or steam during the formation of the rock. Mortared joints were not observed between the masonry units. **See Appendix Photo 5.**

The masonry foundations for the Barn are in poor condition. Mortared joints were not observed and the exterior foundations did not extend down for frost protection. **See Appendix Photo 5.** Without mortared joints, the foundation system does not work together as a single unit and thus the structure is susceptible to differential vertical and some horizontal movement. Without frost protection, the structure is highly susceptible to vertical movement between seasonal temperature fluctuations. Knowing the above information however was probably of no concern to the original owners, since the structure still is and was used as a Barn.
