HISTORIC STRUCTURE ASSESSMENT

HOUGH BUILDING CORNER OF THIRD AND SILVER STREETS LAKE CITY, COLORADO

PREPARED BY
MARK M. JONES ASSOCIATES, ARCHITECTS, LLC
1085 GRAND AVENUE
DEL NORTE, COLORADO 81132
(719) 657-2070 FAX (719) 657-2072

HISTORIC STRUCTURE ASSESSMENT
State Historical Fund Project #2003-HA-068
June, 2004

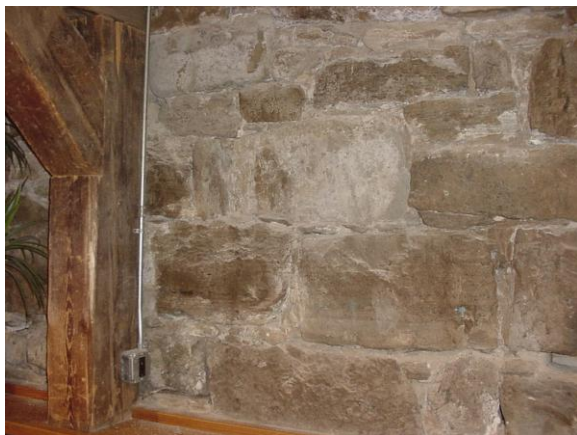
Lower level stone wall

The foundations range between fair and good condition, and are sturdily holding the building in place. The integrity of the stone wall system is fair, having been damaged over time by significant water erosion. The water erosion has occurred at the west and south stone foundation walls. The later installation of sidewalks on the west and south elevation has apparently halted further erosion of the foundation elements at these locations.

For nearly the entire building perimeter, and the central demising foundation wall between building 1 and building 2, the foundations require no corrective work. The west and south foundation walls should be monitored for evidence of further erosion.

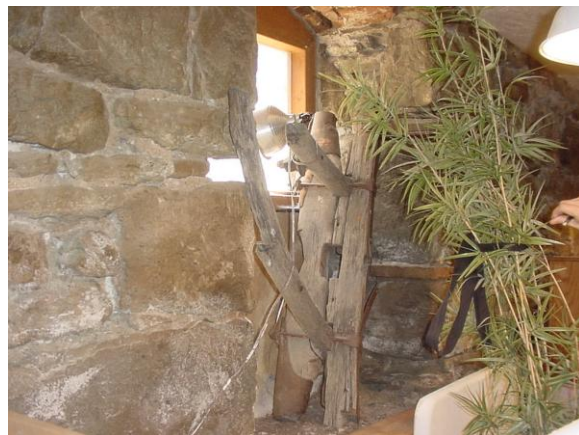
Lower level stone wall with lightwell.

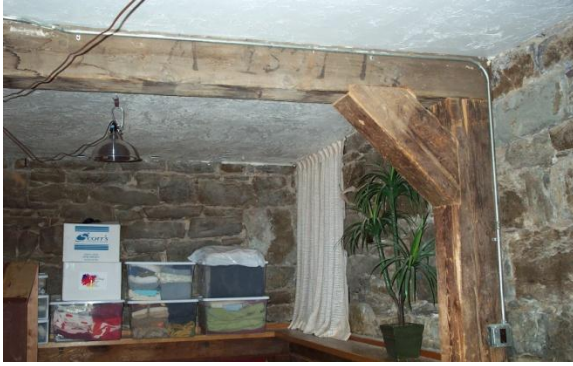
The first floor framing appears to be in good condition. The additional timber framing in the basement is in good condition, and substantially assists in the bearing of first floor loads. The stage appears to be adequately framed to support the live loads of musicians or a drama troop.

Photographs of timber reinforcement construction beneath main floor.

No corrective work is recommended for the first floor structural system.

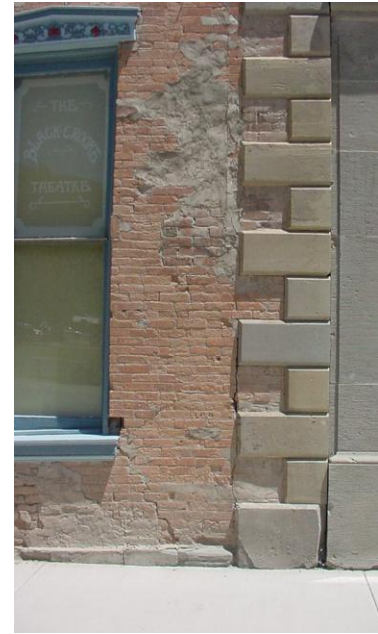
The area at the southeast corner is in poor condition. When this portion was jacked up, the workers were overly exuberant. They jacked the corner of the building up nearly two courses of brick too high. The jacking at this point caused the building to fail at and around its natural weak points at the easterly window and central window of the east wall. This has impacted the masonry walls and has set the window at the southeast corner askew. This window is no longer open to the inside. Instead the opening is infilled with concrete block. No leaks are apparent at the foundation, so apparently foundation drainage is not a problem.

Main level detail.

The second option under consideration would primarily address the stabilization of the overall wall in its present structural condition and the outside appearance. In this measure, the physical configuration of the bearing masonry and the jacks embedded in concrete would remain untouched. The concrete block masonry behind the window would also be kept intact. The real corrective work undertaken would be at the outside wythe of brick. This wythe would be removed from the building up to the decorative band. The window would be removed, disassembled in a shop, reassembled square, restored, and reinstalled. Finally, the exterior wythe of brick would be rebuilt, using as much original material as possible, and using a mortar composition and color close to identical to the original.

Based on the factors previously mentioned: structural stabilization, historical accuracy, and cost effectiveness; the second option is recommended. This recommendation would offer greater structural stability, a historically accurate appearance, and less overall structural intervention, all for a lower total cost. During the course of the preparation of architectural and structural

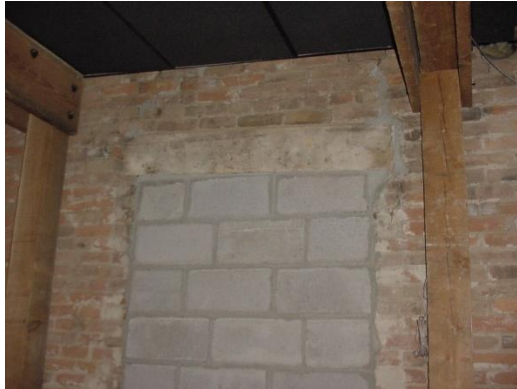
Left: *Hadite cinder block behind south elevation window.*

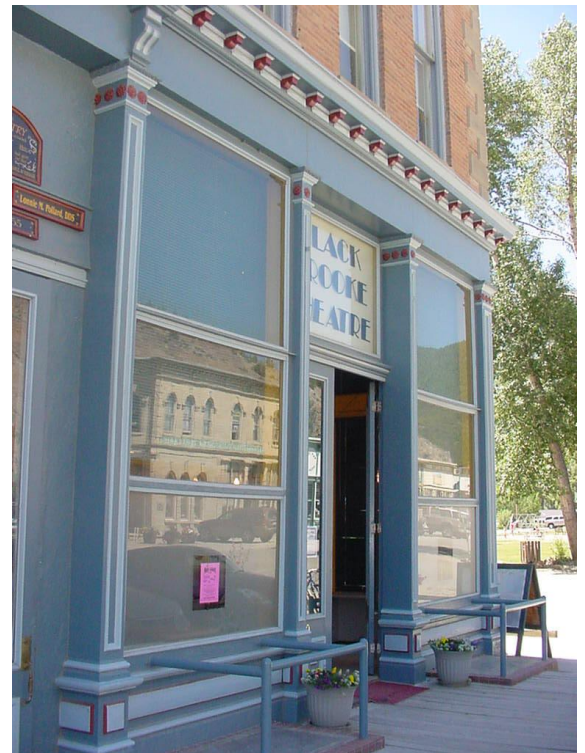
Building section 1: *cast iron pilasters and storefront system.*

No corrective structural work is recommended for the cast iron and stone storefront systems.

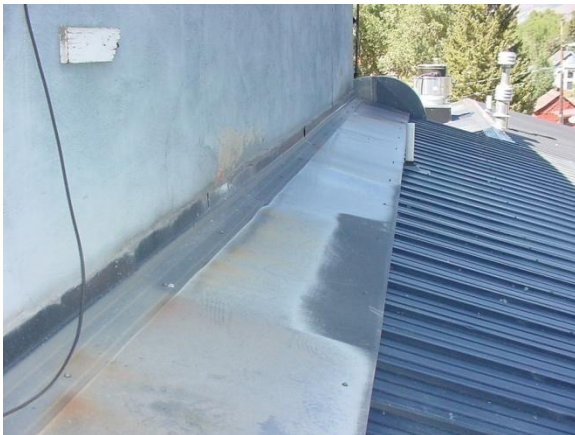
Sheet metal flashing at metal roof

The roof should be monitored for any signs of leakage. No roof replacement is recommended at this time. Approximately ten linear feet of sheet metal flashing at the wall-roof intersection should be removed and replaced.

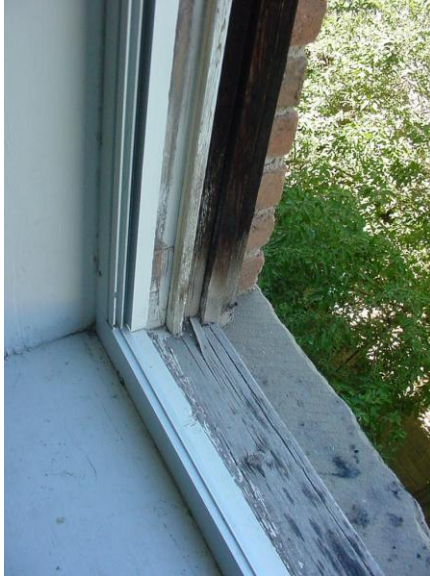
Upper level window: rotted sill.

Windows are all original, and appear to mostly contain their original glazing. Windows generally range from poor to good condition. Most of the windows have been well maintained and painted at the interior, but allowed to succumb to dry rot at the exterior, as depicted above. Paint on the interior of the windows is generally in poor to fair condition, and paint on the exterior of the windows is nearly universally in poor condition.

Determine through laboratory spectrographic analysis whether windows and trim were originally painted or stained, and if painted, what color. Refurbish windows as follows: Using gentlest means possible, remove all chipped and peeled paint from sash and frames only down to the next good paintable surface. Use epoxy filler to patch any damaged areas. Remove cracked glazing putty and re-putty. Prime the sash and frames. Use epoxy filler on cracked sills as needed.

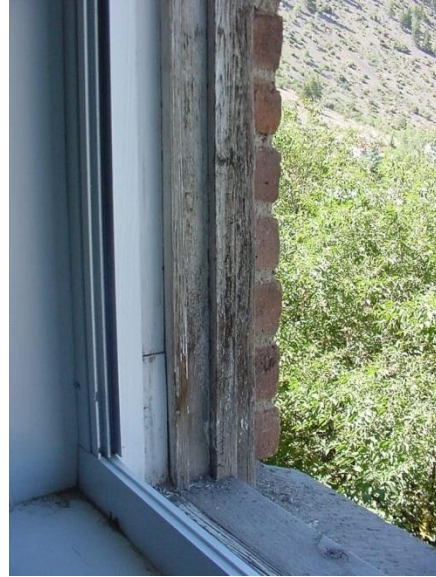
Upper level window: rotted trim.

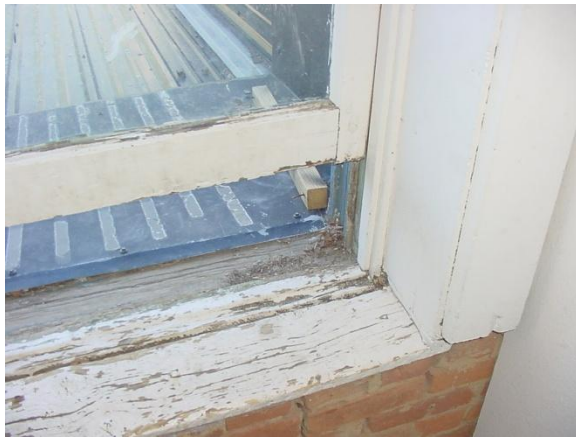
Upper level window: rotted sill

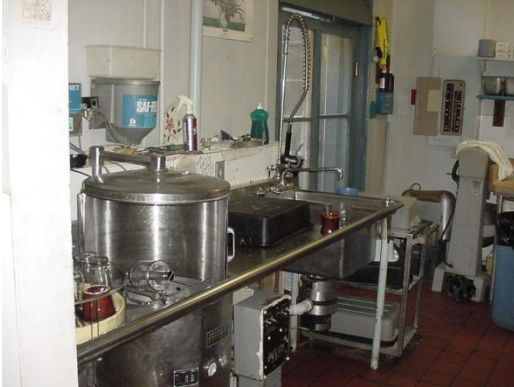
North wall of kitchen.

The original recommendation was to retain the entire kitchen in its existing configuration. However, the needs of the theatre company and needs for vertical circulation take precedence over the utilization of a commercial kitchen for the project. Therefore, it is recommended that the commercial kitchen be dismantled, and most fixtures should be sold.

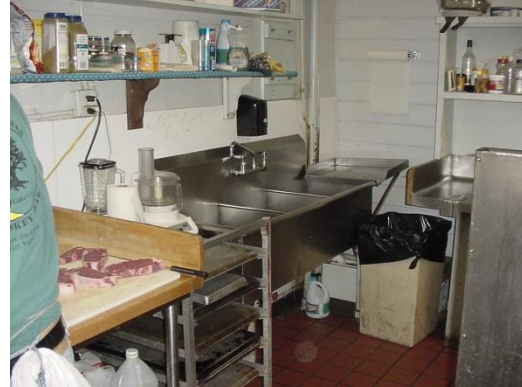
East wall of kitchen with 3 comp. sink.

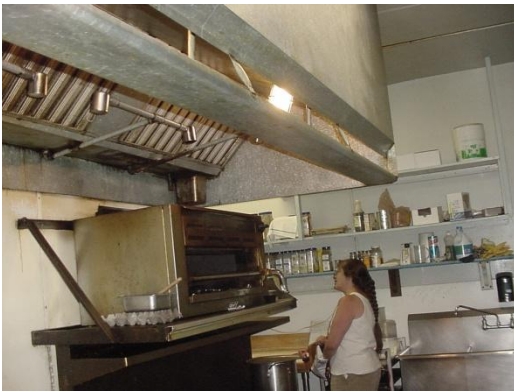
Kitchen, looking east.

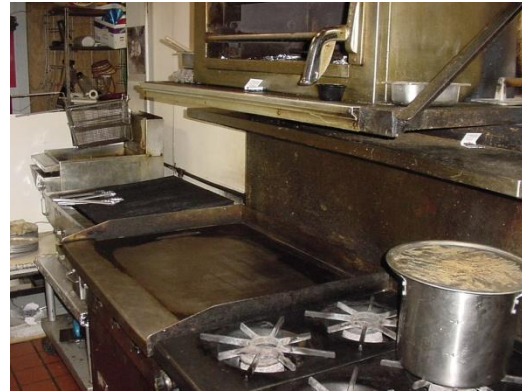
Kitchen, stove and fry top.
