HISTORIC STRUCTURE ASSESSMENT

**SAINT THOMAS THE APOSTLE EPISCOPAL CHURCH
ALAMOSA, COLORADO**

ST. THOMAS THE APOSTLE EPISCOPAL CHURCH
607 4th STREET
ALAMOSA, COLORADO

HISTORIC STRUCTURE ASSESSMENT
State Historical Fund Project # 2003-HA-052
June, 2003

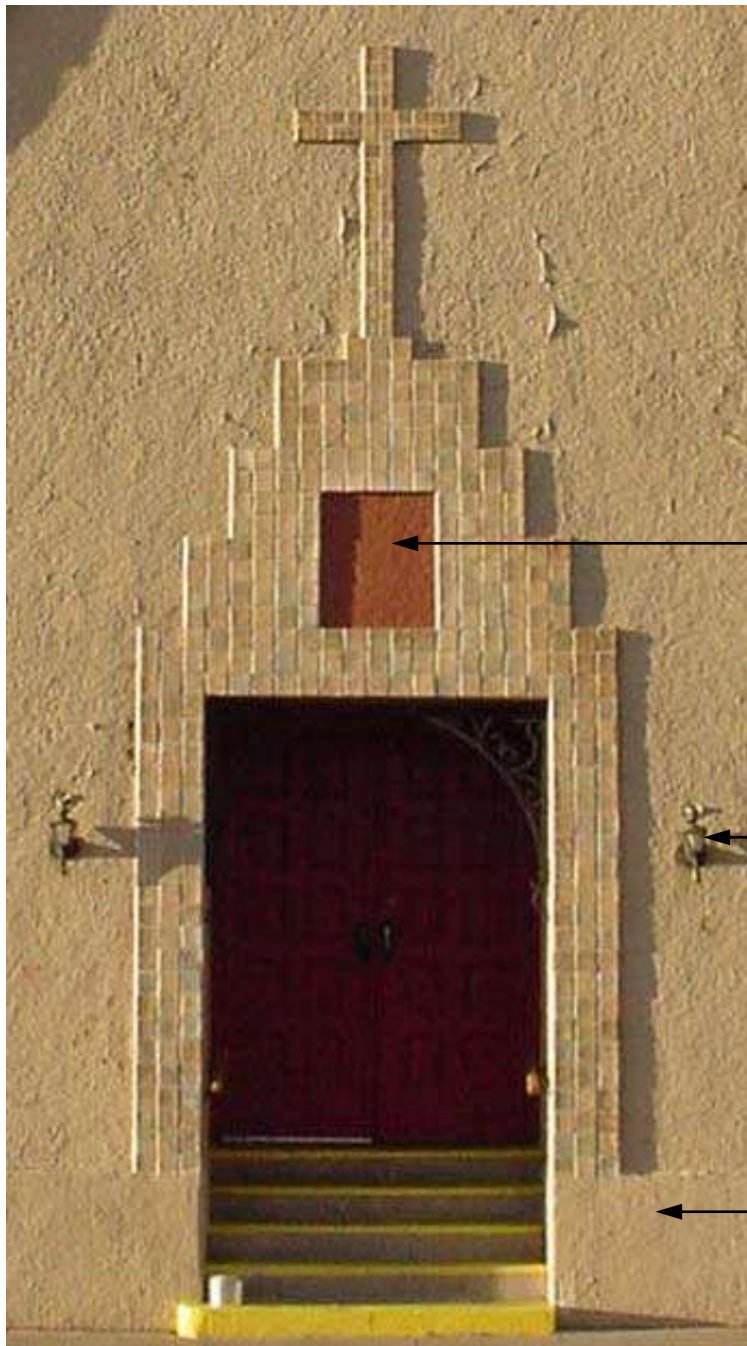
Note: *terra-cotta colored stucco panel at this level.*

Note: *non-original lanterns.*

The stucco finish needs to be completely cleaned and scraped in peeling areas. The stucco should first be tested for any signs of acrylic. If no acrylic is present, the exterior coat of paint should be completely removed with Prosoco Sure-Klean Fast Acting Stripper. Any particularly difficult paint areas should be treated with Prosoco Sure-Klean Heavy Duty Paint Stripper. Any cracks should be investigated to determine whether they are the result of settling. Cracks should be filled as necessary. A unifying finish coat of portland cement color coat stucco with matching texture should then be applied over the Parish Hall and Sanctuary stucco areas. Deteriorated wood trim and blocking should be removed in its entirety and replaced. No corrective work is

recommended for the glazed clay parapet edge. The glazed tile surround should be cleaned, and any abject tiles replaced to match. Grout for new tiles should match color and consistency of surrounding tiles. The original lanterns should be removed from the Sanctuary entry and installed in their original location at the Parish Hall entry. New lanterns should be fabricated for the Sanctuary, and should be exact replicas of the original Parish Hall pair.

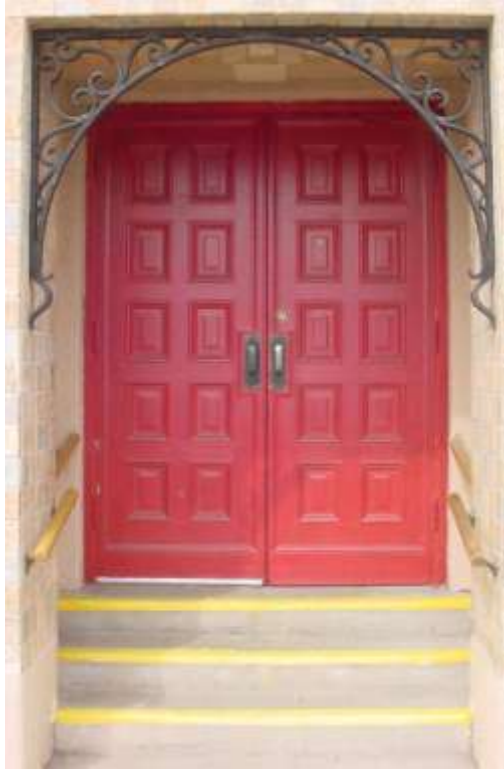
Front Entry Stoop

The main entry stoop is in good condition, excepting the yellow safety lines painted on the nosing of each tread. No landing occurs at the top. The wooden rails installed on either side of the steps are not code compliant. They are not continuous, nor do they extend past the lowest stair. The side entry stoop, also made of concrete, is in fair condition. The stair there is also not code compliant. The treads are not level and the risers are not of even height. These stairs are also missing a top landing. The railing here is low, and is not securely attached to the stairs and the Parish Hall wall. The stoop at the vestibule entry between the church and the Parish Hall is also made of concrete. This stoop does contain a small top landing, but no handrails are present.

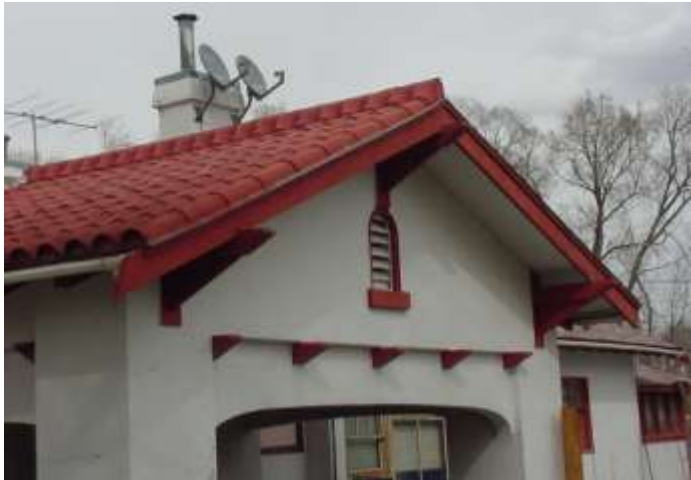
Left: Painted clay roof at Hurley residence.

According to some erroneous testimonies, this tile was removed from Saint Thomas the Apostle Episcopal Church, and sold to the home's owner in the mid 1970s.

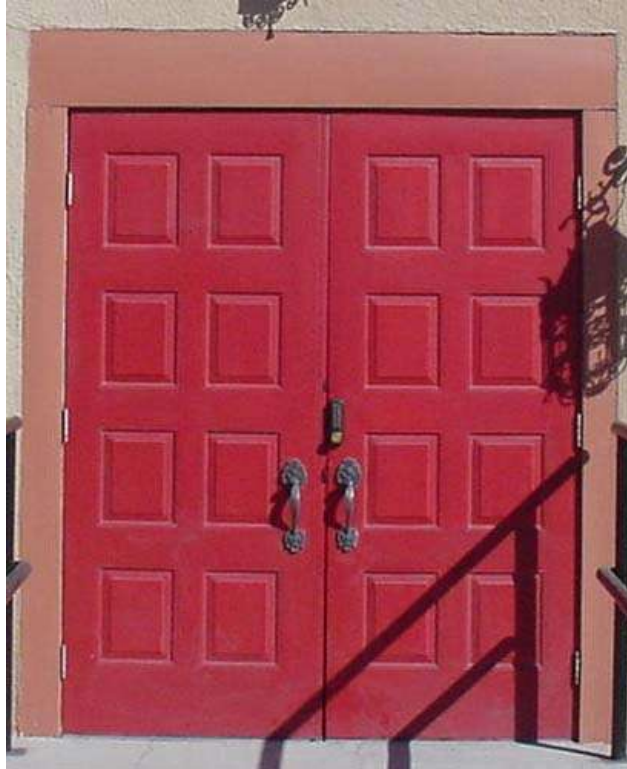
Eight-panel wood entry doors.

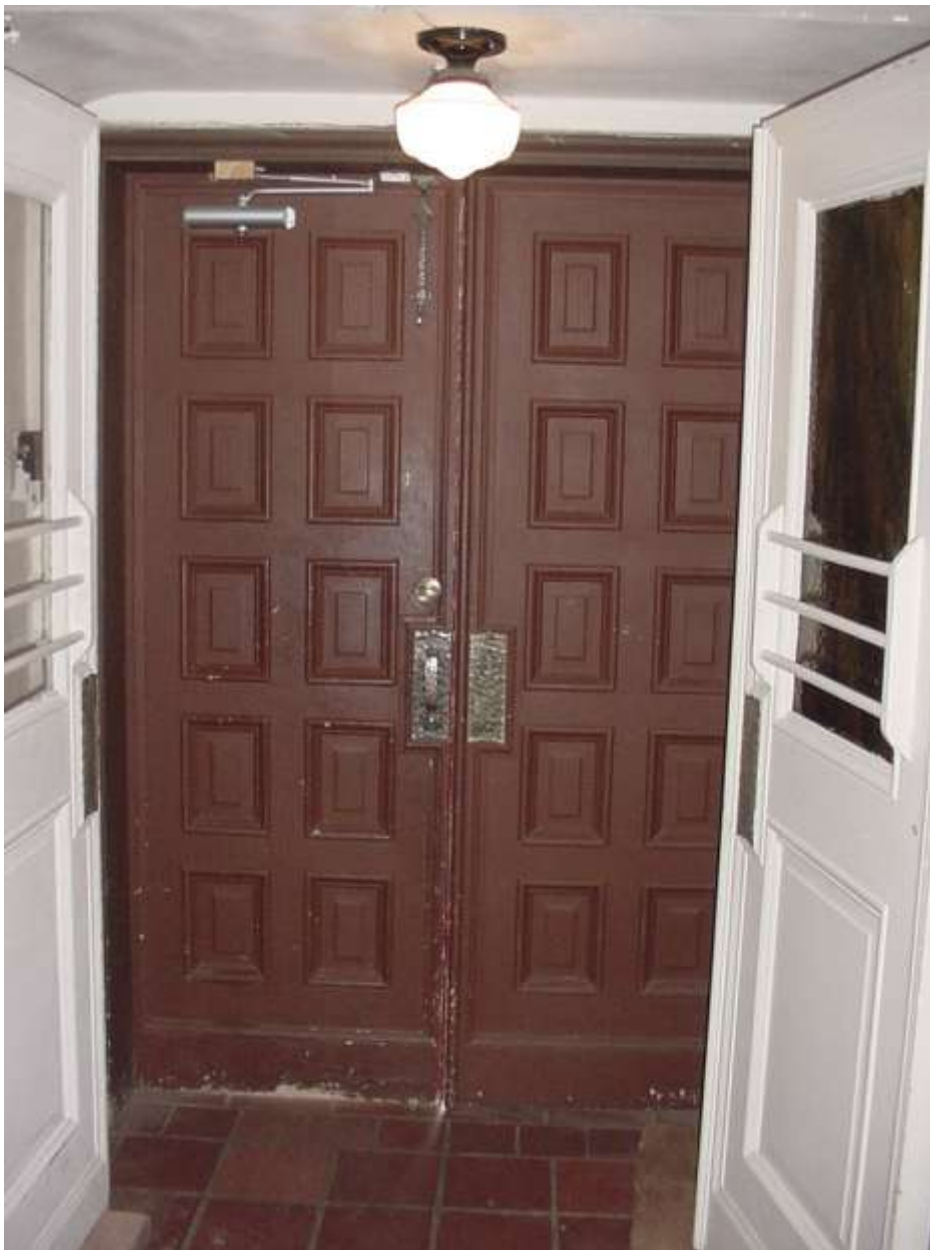
Parish Hall entry doors at interior.

Window condition is generally fair, given the age of the windows. Every surviving wood window is intact with original hardware and glass. Paint on the windows, both inside and out, is also in fair condition. Aluminum sash windows are in good condition, however, these windows in no way visually replicate the originals. Exterior doors are in good condition. Hardware is also in good condition. Several interior doors have had sheet wood veneer placed over the original door faces.

A laboratory spectrographic analysis should be undertaken to determine original colors. Then, all aluminum windows should be removed. Replace these with historic reproduction wood windows with true divided lites in the exact configuration of existing windows. Also include trim to match existing windows. Refurbish wood windows, including all dormer windows, as follows: Using gentlest means possible, remove all chipped and peeled paint from sash and frames only down to the next good paintable surface. Use epoxy filler to patch any damaged areas. Remove cracked glazing putty and re-putty. Prime sash and frames. Use epoxy filler on cracked sills as needed. Follow lead paint protocol. Replace all ropes and reset or replace any missing weights. Install copper weatherstripping. Check all sash for proper operation. Replace any cracked panes. Check leaded windows and repair any bent or broken coming. Check inside finish and reseal with low sheen poly on all areas, especially those that are worn. As an alternate, traditional varnish can be used, but would not be as durable as a poly finish. Remove surface paint from interior sash and frames and restore original finish with stain sealer as needed, and poly finish coat. For interior and exterior doors, attain color samples for laboratory analysis. Any interior doors with sheet veneer faces should have that veneer removed. Then, correct any aberrances and paint door face in a color approximating the original color. The exterior doors are rather scarred from use, and should be sanded and filled with wood putty where appropriate prior to repainting. Repaint the exterior doors in approximately their original color.

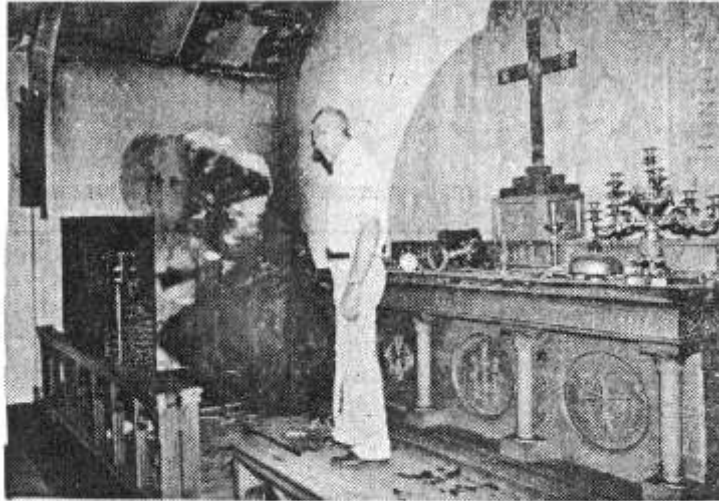
Al Milsom of St. Thomas Episcopal checks where fire began
... smoke, fire damaged vestments and other articles

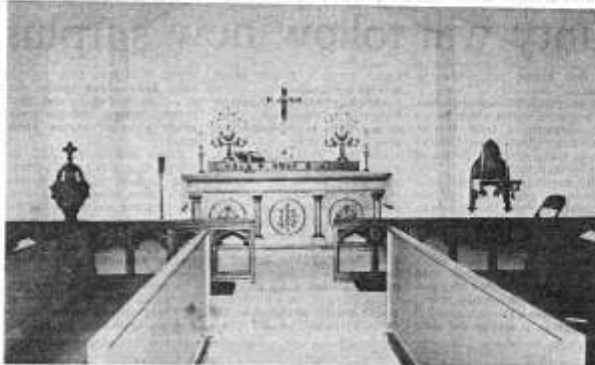
Interior of St. Thomas Episcopal Church in Alamosa ... has been restored following fire during mid-September

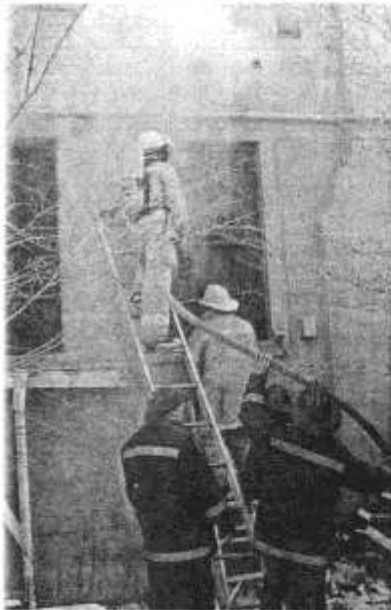
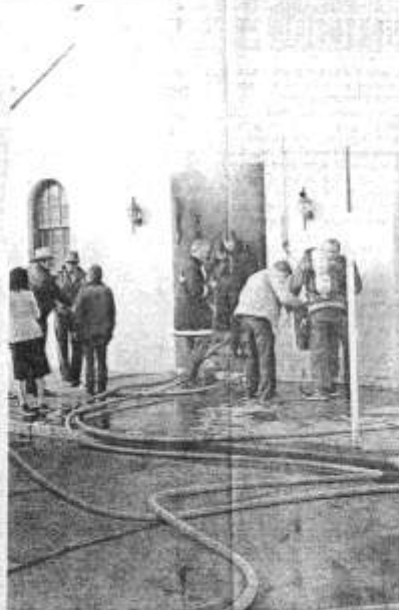
POSSIBILITY OF ARSON PROBED — Smoke pours from a rear window of Alamosa's St. Thomas Episcopal Church as firefighters use the interior of the building in the photo at left. At right,

firefighters prepare to set up a fan at the Fourth St. entrance of the church to clear the interior of smoke. (Courier photos by Fred W. Harris)

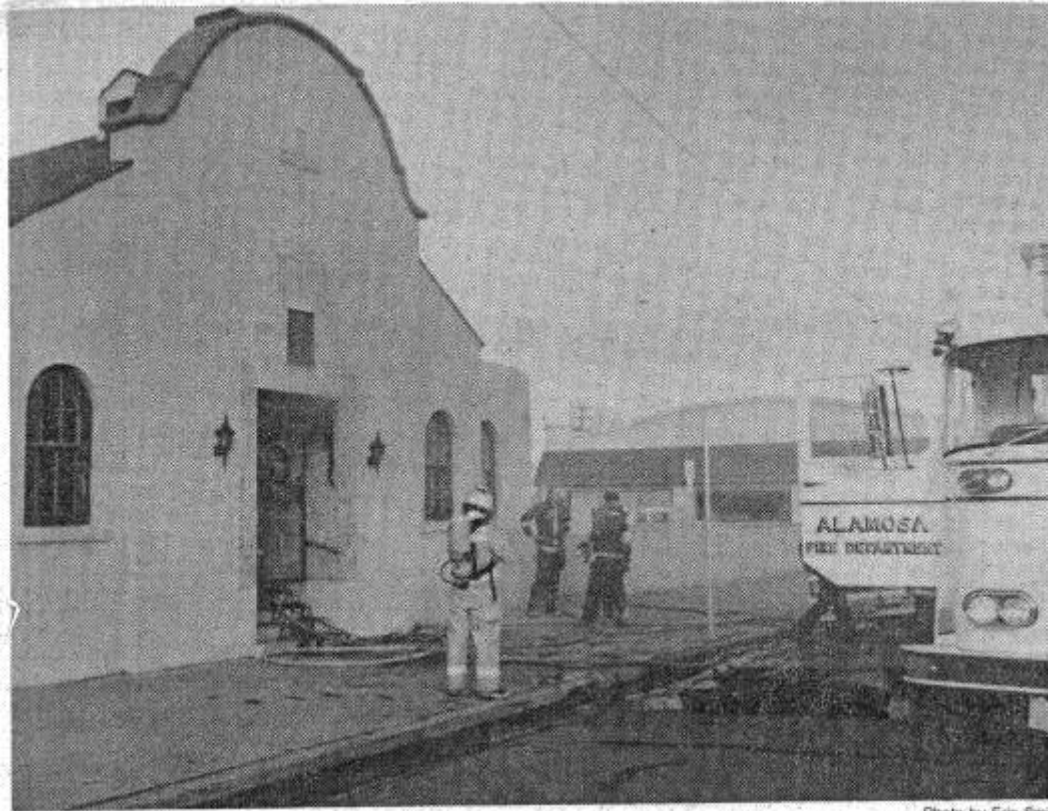
Firefighters work to extinguish a fire at St. Thomas Episcopal Church
the fire broke out in the parish hall on Thursday
