HISTORIC STRUCTURE ASSESSMENT

HOUGH BUILDING CORNER OF THIRD AND SILVER STREETS LAKE CITY, COLORADO

PREPARED BY
MARK M. JONES ASSOCIATES, ARCHITECTS, LLC
1085 GRAND AVENUE
DEL NORTE, COLORADO 81132
(719) 657-2070 FAX (719) 657-2072

HISTORIC STRUCTURE ASSESSMENT
State Historical Fund Project #2003-HA-068
June, 2004

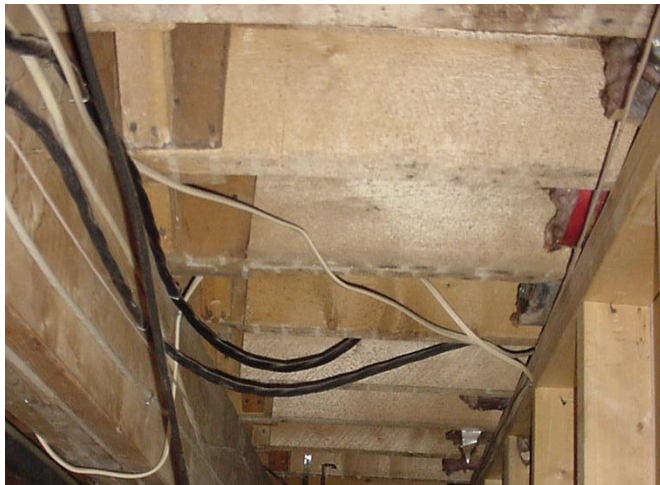
The first floor framing appears to be in good condition. The additional timber framing in the basement is in good condition, and substantially assists in the bearing of first floor loads. The stage appears to be adequately framed to support the live loads of musicians or a drama troop.

Left: *2x10 first floor framing visible at Building 2 kitchen crawl space. Note 2x6 knee wall at right.*

No corrective work is recommended for the first floor structural system.

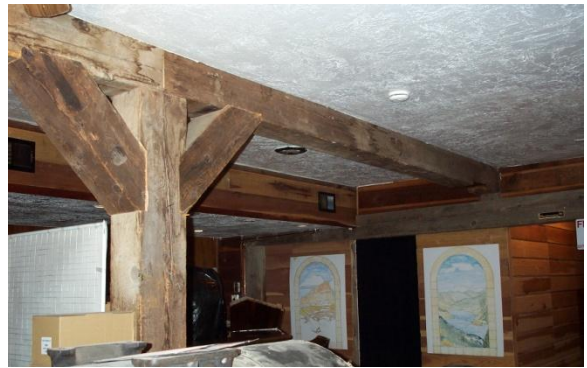
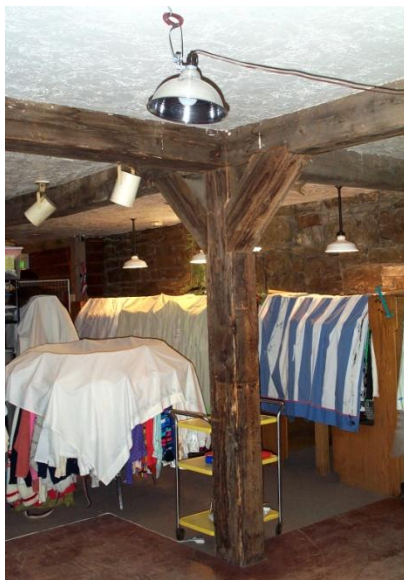
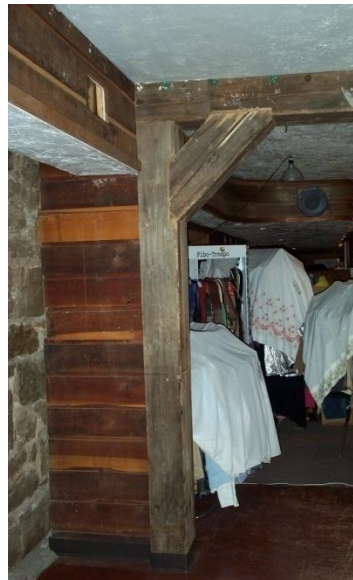
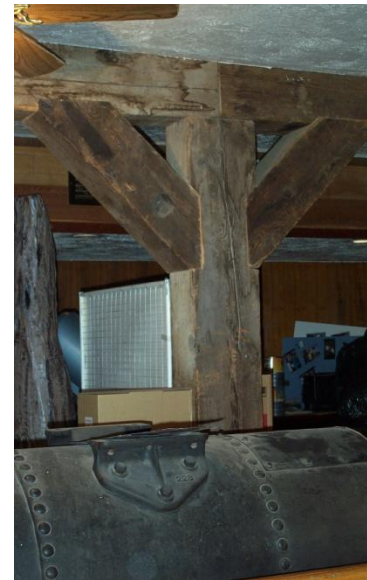
Photographs of timber reinforcement construction beneath main floor.

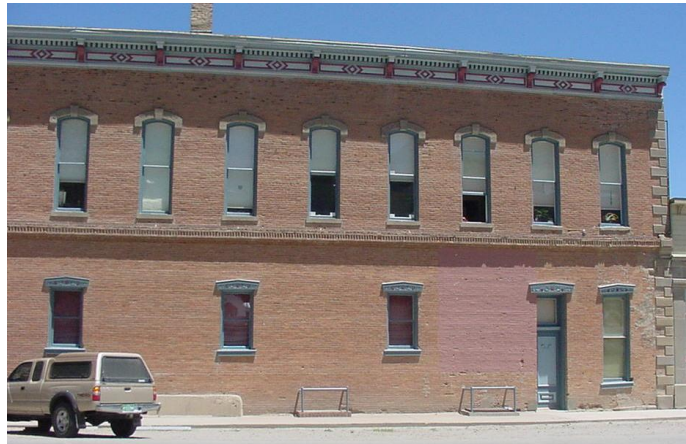
Above: *East end of south wall.*
Left: *Perspective view of south wall from southwest corner.*

In photographs on preceding page, note dull red painted sections. This is where the original Patz and Richards sign and later signs were painted.

The exterior brick, for the most part, is in good condition. The brick is relatively soft and at the south elevation has been subject to graffiti carvings. Some of these carvings include dates, as early as the mid-1880s. The dull red painted sections of the south wall detract from the overall appearance of the wall. The cast iron and architectural sheet metal elements of the building are painted in an attractive palette, but without laboratory analysis, it is impossible to discern whether these colors are original. The sandstone and limestone storefront elements of building 2 are weathered, but generally appear to be in good condition. The stone at the north elevation is also in fair to good condition.

It has been determined that attempts to remove the graffiti carvings would cause more damage than the carvings themselves. The dull red paint should be removed with a mild solution of Prosoco paint remover. Sand or water blasting should not be undertaken on the building, nor should the brick be painted. Consideration should be given to restoring the historic painted signs, since they are valid historic fabric. The presence of these signs would pay tribute to an earlier time in the history of Lake City. If the owner opts to restore the signs at any one of their historic periods, a layered paint removal process would need to be employed. Samples should be carefully removed at the cast iron and architectural sheet metal, and should be sent to a laboratory for spectrographic analysis. Once the original colors have been determined, these portions of the building should be cleaned down to the next good paintable layer. The cast iron and architectural sheet metal should then be painted in a close approximation of their original colors. The sandstone and limestone storefront elements of building 2 should be cleaned with a mild solution of restoration cleaner. No finish work is recommended to the stone masonry at the north elevation of the building.

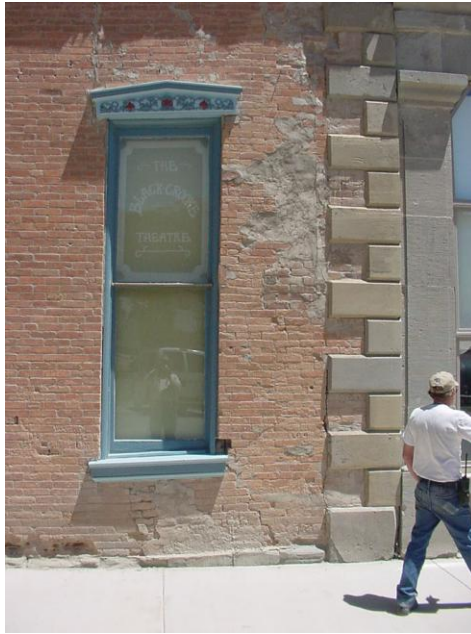
The area at the southeast corner is in poor condition. When this portion was jacked up, the workers were overly exuberant. They jacked the corner of the building up nearly two courses of brick too high. The jacking at this point caused the building to fail at and around its natural weak points at the easterly window and central window of the east wall. This has impacted the masonry walls and has set the window at the southeast corner askew. This window is no longer open to the inside. Instead the opening is infilled with concrete block. No leaks are apparent at the foundation, so apparently foundation drainage is not a problem.

Main level with window.

The second option under consideration would primarily address the stabilization of the overall wall in its present structural condition and the outside appearance. In this measure, the physical configuration of the bearing masonry and the jacks embedded in concrete would remain untouched. The concrete block masonry behind the window would also be kept intact. The real corrective work undertaken would be at the outside wythe of brick. This wythe would be removed from the building up to the decorative band. The window would be removed, disassembled in a shop, reassembled square, restored, and reinstalled. Finally, the exterior wythe of brick would be rebuilt, using as much original material as possible, and using a mortar composition and color close to identical to the original.

Based on the factors previously mentioned: structural stabilization, historical accuracy, and cost effectiveness; the second option is recommended. This recommendation would offer greater structural stability, a historically accurate appearance, and less overall structural intervention, all for a lower total cost. During the course of the preparation of architectural and structural

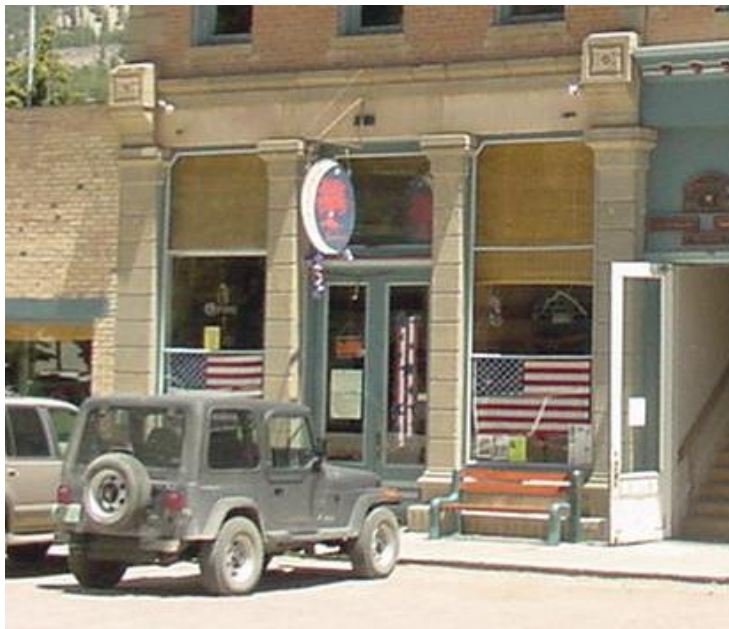
Building section 2: *stone pilasters and storefront system*

No corrective structural work is recommended for the cast iron and stone storefront systems.

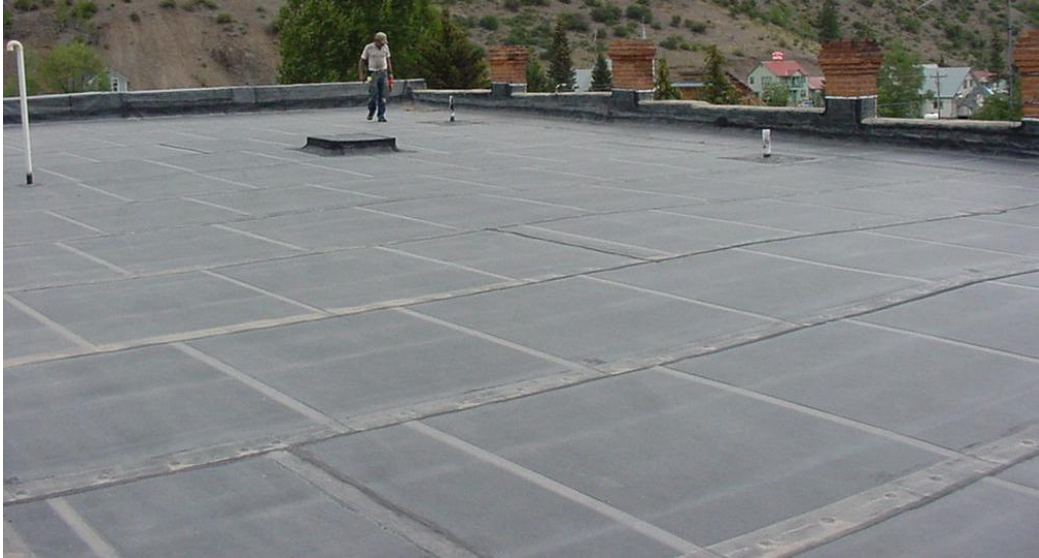
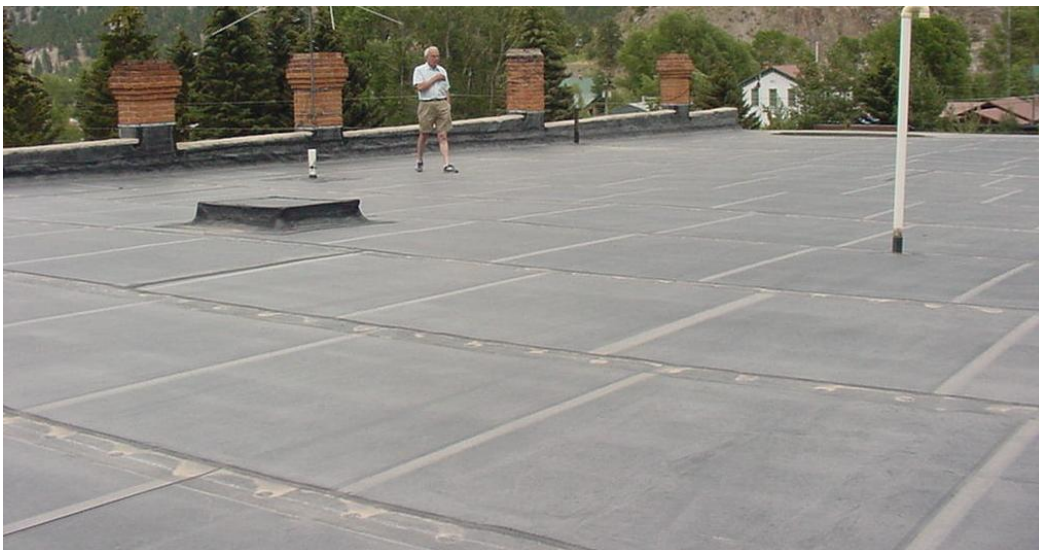
The rubber roofing system appears to be in good condition. All seams are intact and parapet flashing appears to be in good condition. The building maintenance worker, Mr. Charlie Curtis, reports that since this roofing system has been installed, no leaks have been reported. No signs of leakage were apparent on the second level, directly below this roof. The metal seamed roofing system appears to be in fair condition. The sheet metal flashing at the building edge is intact, but some has begun to rust from exposure to the elements.

Above: *Rubber roofing system, looking west.* Below: *Looking east.*

The roof should be monitored for any signs of leakage. No roof replacement is recommended at this time. Approximately ten linear feet of sheet metal flashing at the wall-roof intersection should be removed and replaced.

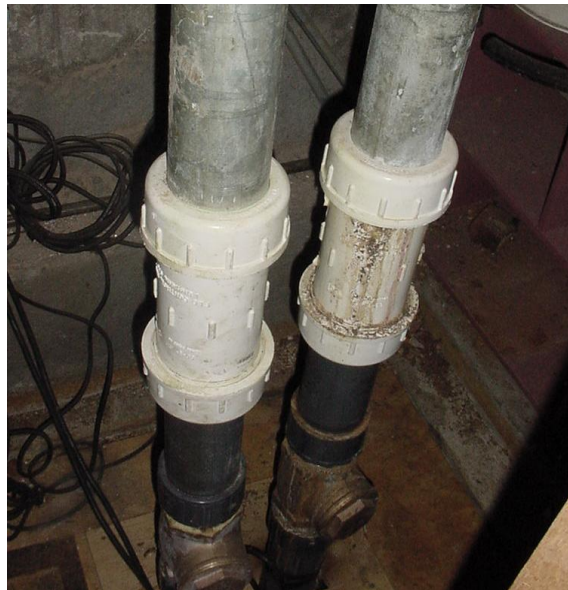
The water service from the street is galvanized steel. After the shut-off valve in the building, it is run in schedule 20 PVC pipe for a short distance. The use of PVC pipe does not meet the requirements of the existing plumbing code. While the use of PVC pipe does not pose a health hazard, it does have significantly less strength than comparable copper pipe, leading to the possibility of a rupture and subsequent flooding of the basement level of the building.

Above: *Domestic water service entry.*
Right: *Lower level pump station.*

The water service should be replaced with a 2" type AK copper pipe. At the time of the replacement, consideration should be given to the installation of a larger 4" service which would allow the building to be fire sprinkled in the future
